# **Fitzroy Basin Association**

Fish Barrier Prioritisation Update 2015

Tim Marsden

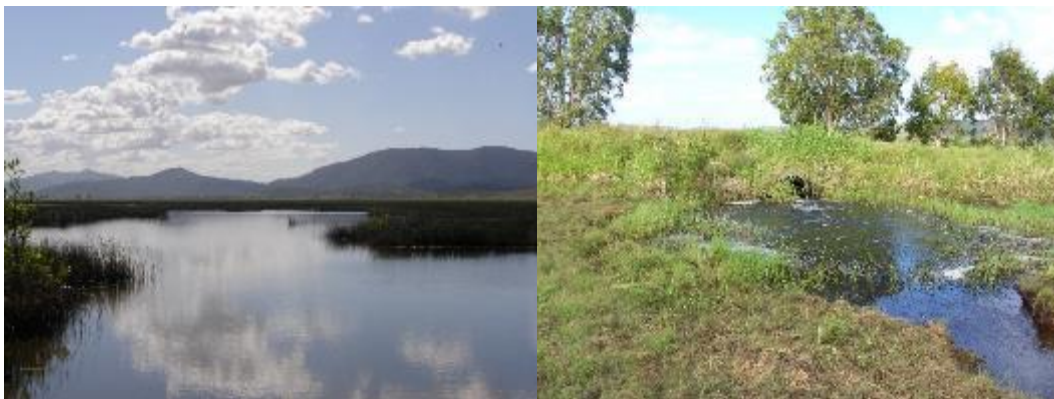
**Figure 6. Left. Tidal interface ponded pasture (Nankin) at the mouth of the Fitzroy River. Right. Barrier to fish migration (pipe), on a tidal interface ponded pasture at the mouth of Waterpark Creek.**

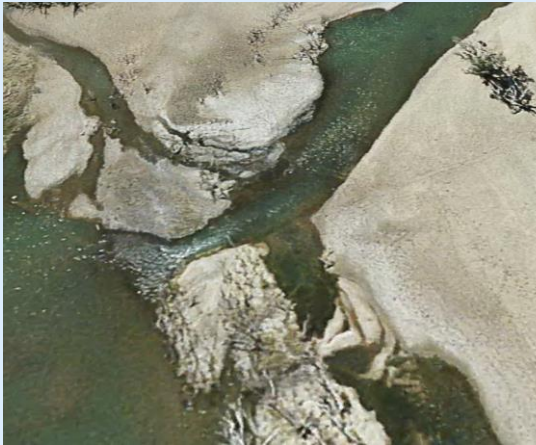
Overall Priority	1

Barrier ID	524	
Stream Name	Fitzroy River	
Barrier Name	Redbank Crossing	
Barrier Type	Crossing	
Comments	Barrier may no longer exist, needs to be confirmed. Incorporation of fishway required if crossing established	
Remediation Solution	Rock Ramp Fishway

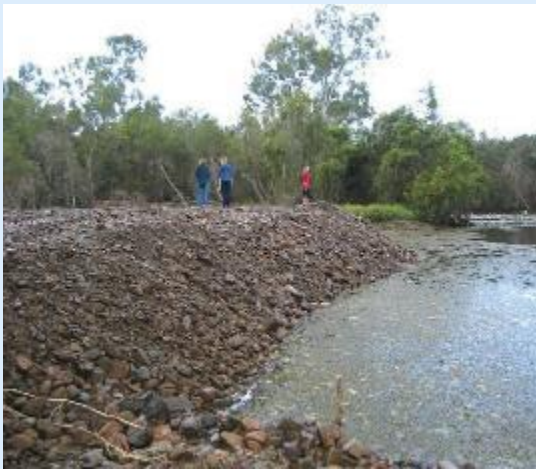
Overall Priority	2

Barrier ID	1000	
Stream Name	Boyne River	
Barrier Name	Mann's Weir	
Barrier Type	Earthen weir	
Comments	Weir is a 3m high semi-permanent barrier. Has been more permanent in recent times	
Remediation Solution	Rock Ramp Fishway

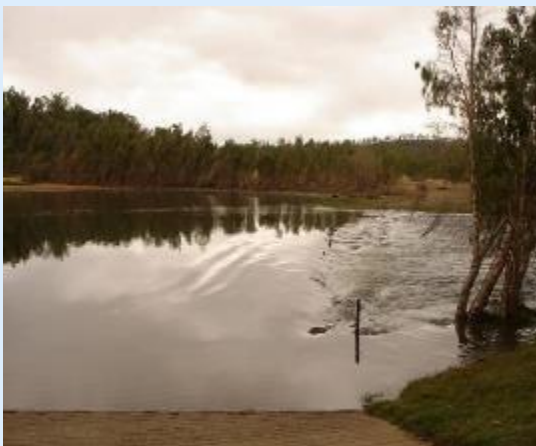
Overall Priority	3

Barrier ID	523	
Stream Name	Fitzroy River	
Barrier Name	Hanrahan's Crossing	
Barrier Type	Causeway	
Comments	Low causeway that creates 0.5m jump. Formalisation of D/S ramp required	
Remediation Solution	Rock Ramp Fishway

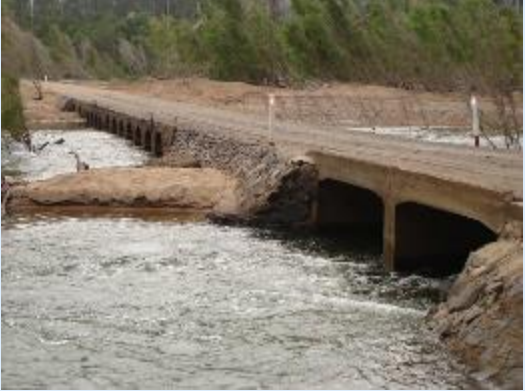
Overall Priority	4

Barrier ID	3951	
Stream Name	Fitzroy River	
Barrier Name	Glenroy Crossing	
Barrier Type	Causeway/culverts	
Comments	Permanent crossing that is barrier at low flows. Fish passage can be provided through culverts at low flows	
Remediation Solution	Baffles/Rock Ramp Fishway

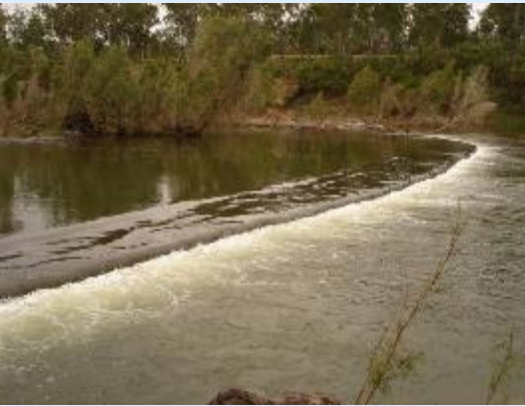
Overall Priority	5

Barrier ID	3952	
Stream Name	Fitzroy River	
Barrier Name	Craiglee Crossing	
Barrier Type	Causeway	
Comments	Low causeway that creates a 0.5m drop at low flows. Formalisation of downstream ramp require to prevent drops	
Remediation Solution	Rock Ramp Fishway

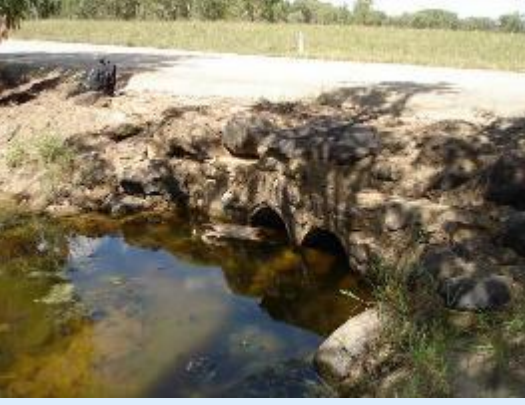
Overall Priority	6

Barrier ID	535	
Stream Name	Amity Creek	
Barrier Name	Wamalgi Rd	
Barrier Type	Pipes	
Comments	Pipe create high velocities not passable by fish. No way to use existing structure must be replaced	
Remediation Solution	Baffled culverts

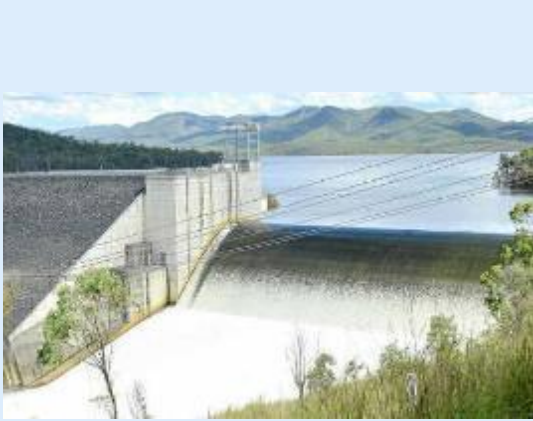
Overall Priority	7

Barrier ID	9001	
Stream Name	Boyne River	
Barrier Name	Awonga Dam	
Barrier Type	Dam	
Comments	Large dam that would require extensive modification to provide passage	
Remediation Solution	Fish Lift

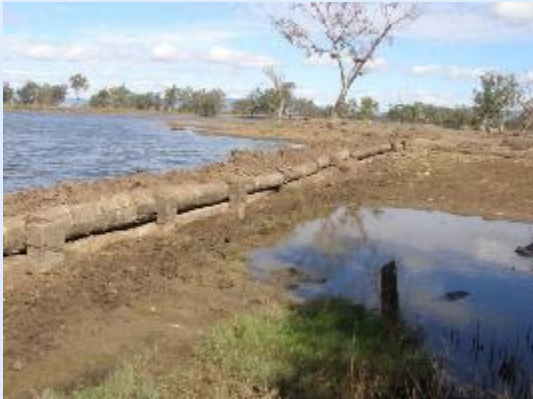
Barrier ID	6169	
Stream Name	Serpentine Lagoon	
Barrier Name		
Barrier Type	Tidal Bund	
Comments	Small tidal bund required to create ponded pasture. A fixed water level fishway required	
Remediation Solution	Rock Ramp Fishway

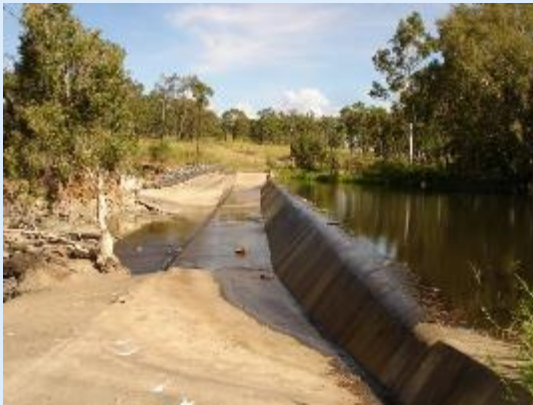
Barrier ID	9393	
Stream Name	St Lawrence Creek	
Barrier Name	St Lawrence Weir	
Barrier Type	Weir	
Comments	4m high weir located at tidal interface. Difficult site but well worth consideration	
Remediation Solution	Cone Fishway

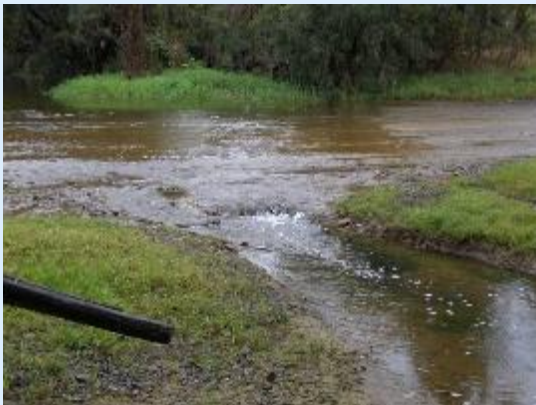
Barrier ID	8652	
Stream Name	Calliope River	
Barrier Name	Blackgate Rd	
Barrier Type	Causeway/Pipe	
Comments	Low causeway with pipe, stabilisation of D/S channel to create a wet crossing	
Remediation Solution	Rock Ramp Fishway

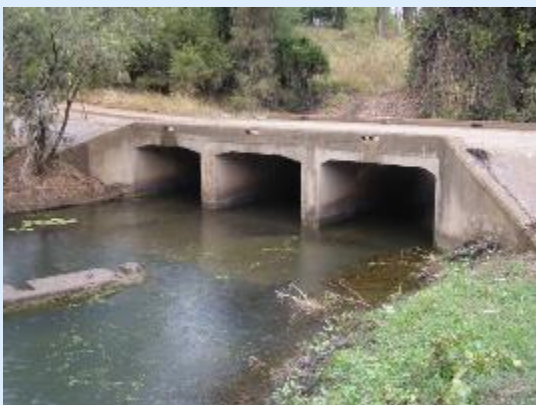
Barrier ID	8618	
Stream Name	Calliope River	
Barrier Name	Mt Alma Rd	
Barrier Type	Culverts	
Comments	Culverts barrier at high flows, installing devices to provide low flow zone at high flow required	
Remediation Solution	Baffled culverts

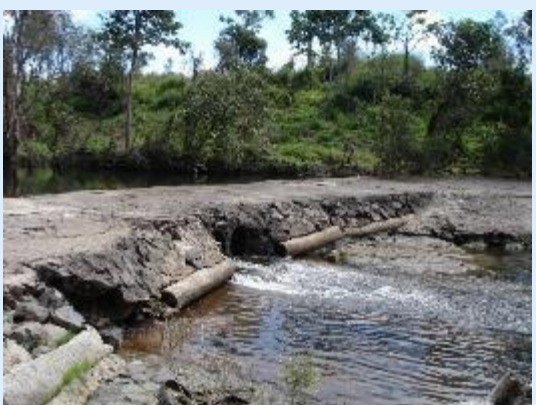
Barrier ID	8677	
Stream Name	Clairview Creek	
Barrier Name	Clairview Weir	
Barrier Type	Causeway	
Comments	Low weir with pipes at tidal interface. Site requires set headwater level as local water supply	
Remediation Solution	Rock Ramp Fishway/Culverts

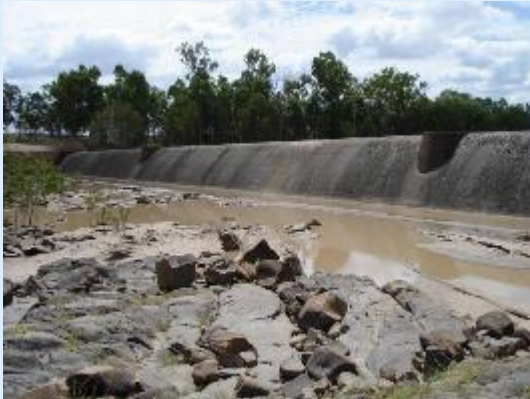
Barrier ID	2	
Stream Name	Mackenzie River	
Barrier Name	Tartrus Weir	
Barrier Type	Weir	
Comments	Large weir owned by Sunwater. Design for fishway partially undertaken but likely to cost around \$4M	
Remediation Solution	Vertical Slot Fishway

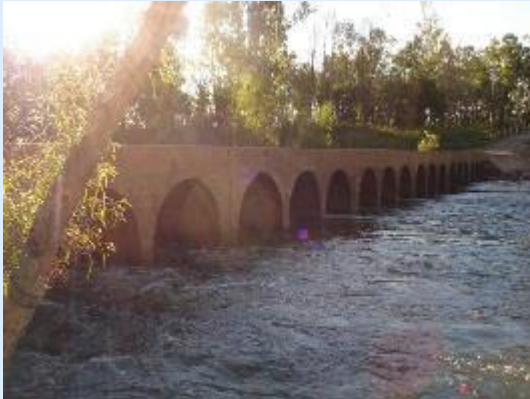
Barrier ID	525	
Stream Name	Mackenzie River	
Barrier Name	Duaringa - Apis Rd	
Barrier Type	Pipes	
Comments	Many barrelled culvert requires baffles installed in at least two culvert barrels	
Remediation Solution	Baffles

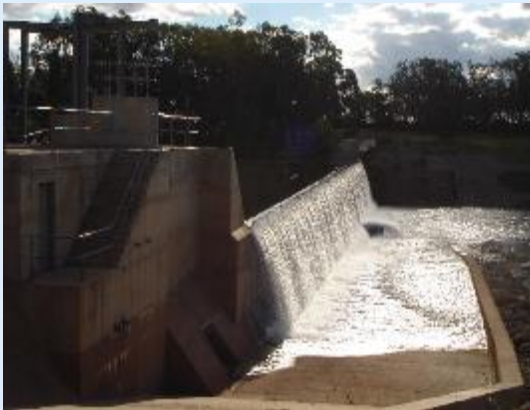
Barrier ID	3	
Stream Name	Mackenzie River	
Barrier Name	Bingegang Weir	
Barrier Type	Weir	
Comments	High weir that has facility for fish lock already incorporated into design. Structure owned by Sunwater	
Remediation Solution	Fish Lock

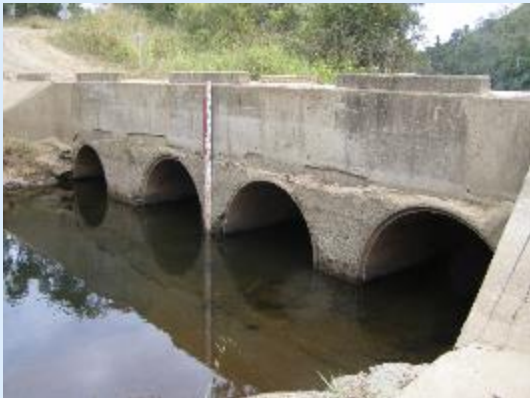
Barrier ID	8354	
Stream Name	Boyne River	
Barrier Name	Pikes Crossing	
Barrier Type	Pipes	
Comments	Pipe culvert requires baffles installed in the two outer culvert barrels. Structure generally has water through the structure	
Remediation Solution	Baffles

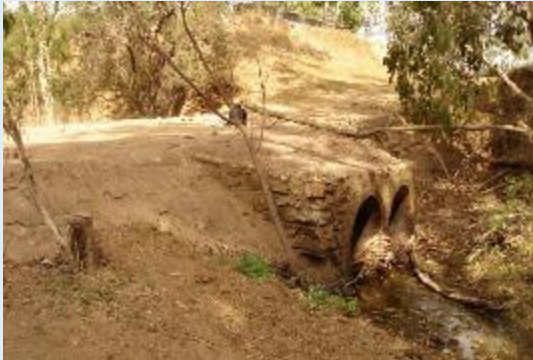
Barrier ID	8716	
Stream Name	Amity Creek	
Barrier Name	Old Hwy	
Barrier Type	Pipes	
Comments	Old pipe culvert structure that would need to be replaced with new box culverts with baffles on the outside two culvert barrel walls	
Remediation Solution	Baffled culverts

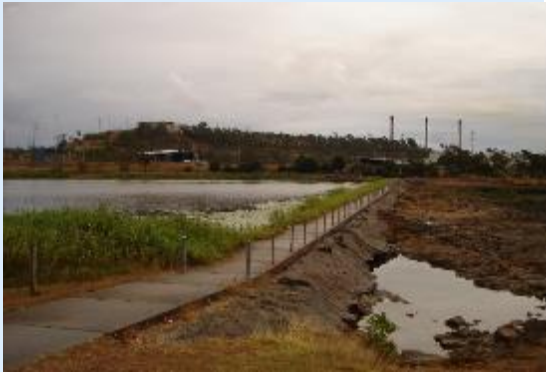
Barrier ID	9718	
Stream Name	Police Creek	
Barrier Name	Lake Callemonda	
Barrier Type	Causeway	
Comments	Fishway design has been completed for this structure and will be constructed Dec 2015	
Remediation Solution	Rock Ramp Fishway

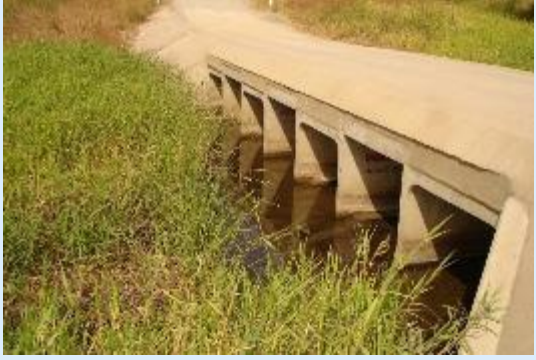
Barrier ID	25	
Stream Name	Raglan Creek	
Barrier Name	Langmom Rd	
Barrier Type	Culverts	
Comments	Many barrelled culvert requires baffles installed in at least two culvert barrels	
Remediation Solution	Baffles

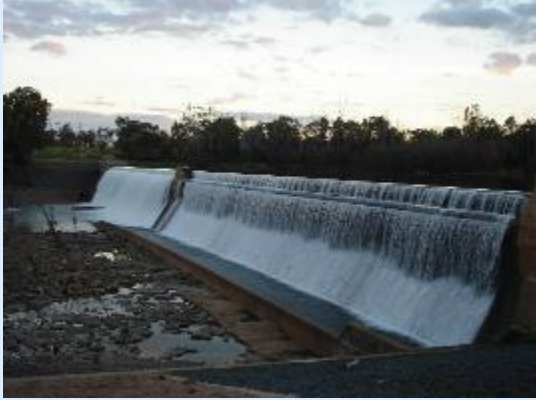
Barrier ID	4	
Stream Name	Mackenzie River	
Barrier Name	Bedford Weir	
Barrier Type	Weir	
Comments	High weir that has facility for fish lock already incorporated into design. Structure owned by Sunwater	
Remediation Solution	Fish Lock

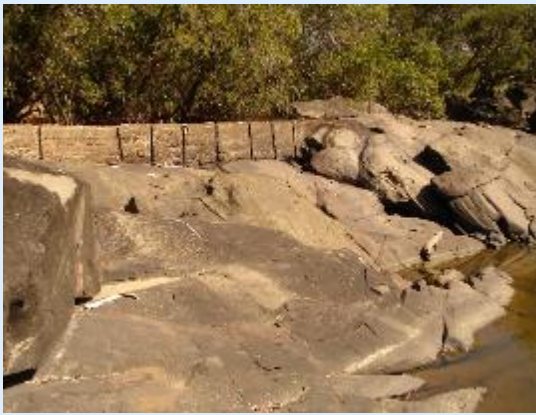
Barrier ID	534	
Stream Name	Montrose Creek	
Barrier Name	Town weir	
Barrier Type	Weir	
Comments	Small weir structure with bedrock base, a channel and cone fishway could be constructed across rock bar	
Remediation Solution	Cone Fishway

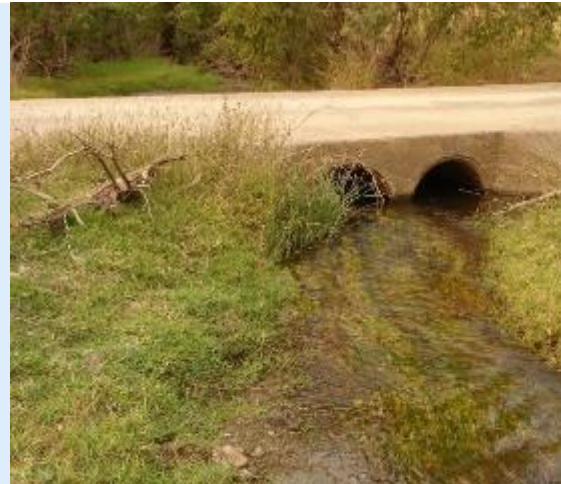
Overall Priority	22
Barrier ID	22
Stream Name	Raglan Creek
Barrier Name	Upper Raglan
Barrier Type	Causeway/Pipes
Comments	Small pipe culvert crossing that should be replaced with baffled box culverts
Remediation Solution	Baffled culverts

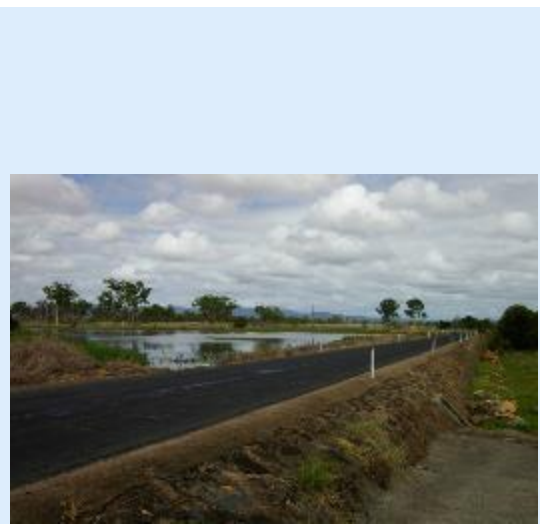
Overall Priority	23
Barrier ID	85
Stream Name	8 Mile Creek
Barrier Name	Bajool Weir
Barrier Type	Weir
Comments	Lareg weir/road, design of fish previously completed, but would require redesign to bring to modern specification. Main road makes construction difficult
Remediation Solution	Cone Fishway

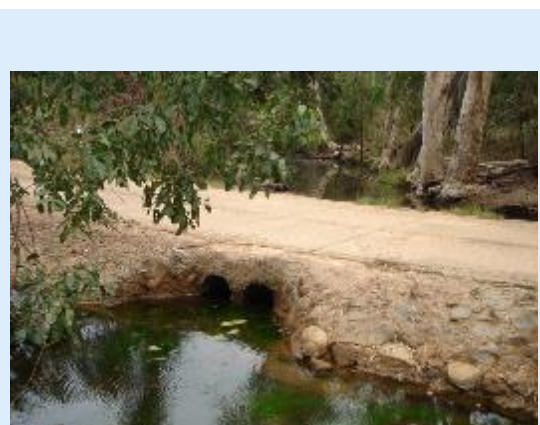
Overall Priority	24
Barrier ID	9165
Stream Name	Black Swan Creek
Barrier Name	Flinders Rd
Barrier Type	Pipes
Comments	Small pipe culvert crossing that should be replaced with baffled box culverts
Remediation Solution	Baffled culverts

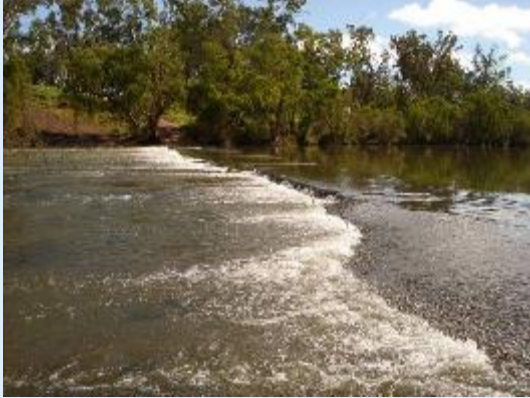
Overall Priority	25

Barrier ID	3015	
Stream Name	Mackenzie River	
Barrier Name	Tartrus Rd	
Barrier Type	Causeway	
Comments	Low causeway that creates a 0.5m drop at low flows. Formalisation of downstream ramp require to prevent drops	
Remediation Solution	Rock Ramp Fishway

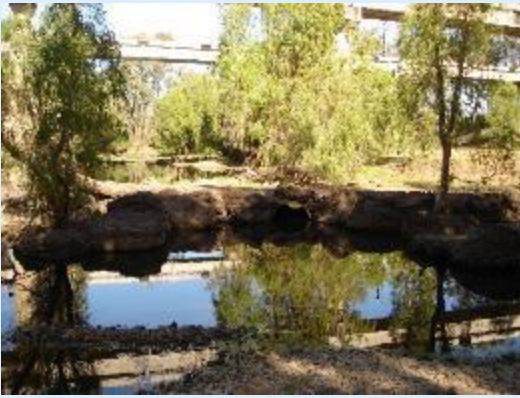
Barrier ID	4152	
Stream Name	Dawson River	
Barrier Name	Boolburra Rd	
Barrier Type	Causeway/Pipe	
Comments	Moderate sized pipe culvert crossing that should be replaced with baffled box culverts	
Remediation Solution	Baffled culverts

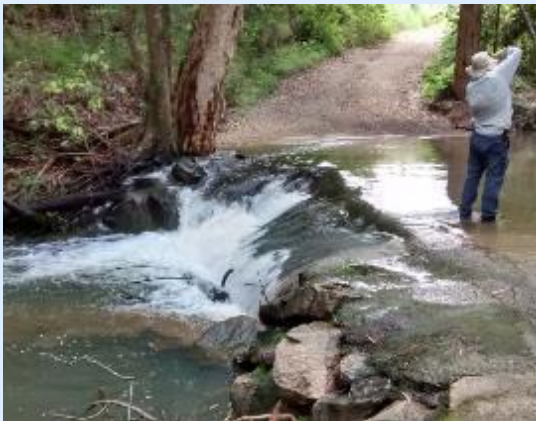
Barrier ID	528	
Stream Name	Stoney Creek	
Barrier Name	Daddys Crossing	
Barrier Type	Causeway/Pipes	
Comments	Moderate sized pipe culvert crossing that should be replaced with baffled box culverts	
Remediation Solution	Baffled culverts

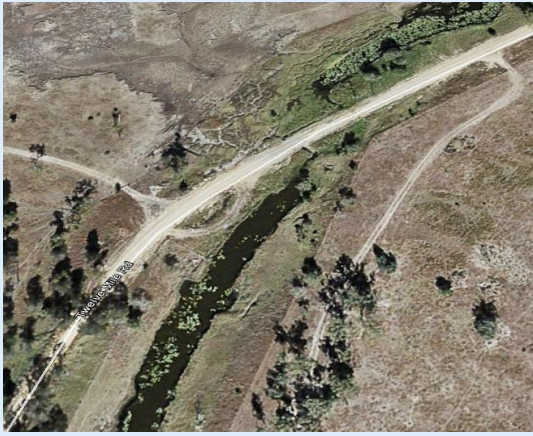
Barrier ID	82	
Stream Name	12 Mile Creek	
Barrier Name	12 mile Rd	
Barrier Type	Pipes	
Comments	Moderate sized pipe culvert crossing that should be replaced with baffled box culverts	
Remediation Solution	Baffled culverts

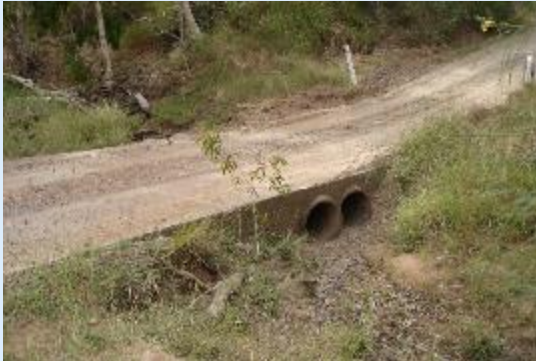
Barrier ID	8731	
Stream Name	Stoodleigh Creek	
Barrier Name	Barretts Rd	
Barrier Type	Pipes	
Comments	Small pipe culvert crossing that should be replaced with baffled box culverts	
Remediation Solution	Baffled culverts

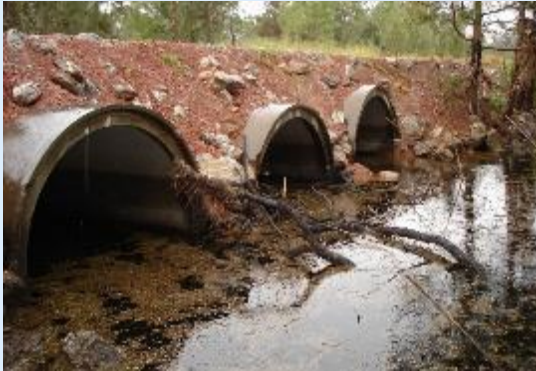
Barrier ID	9629	
Stream Name	Sandy Creek	
Barrier Name	Railway Line Rd	
Barrier Type	Pipes	
Comments	Moderate sized pipe culvert crossing that should be replaced with baffled box culverts	
Remediation Solution	Baffled culverts

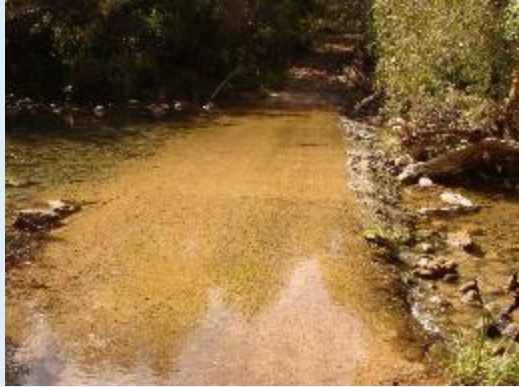
Barrier ID	530	
Stream Name	Stoney Creek	
Barrier Name	Freemans Crossing	
Barrier Type	Causeway	
Comments	Low causeway that creates a small drop at low flows. Formalisation of downstream ramp require to prevent drops	
Remediation Solution	Rock Ramp Fishway

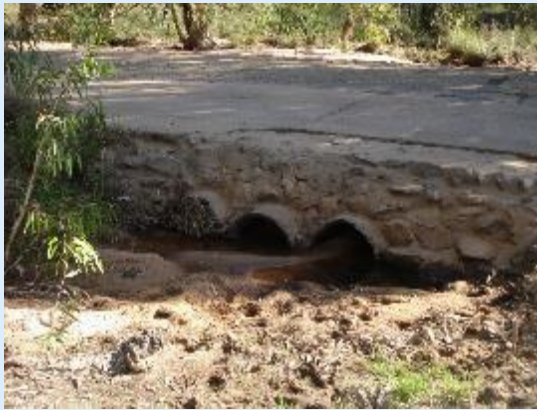
Barrier ID	9000	
Stream Name	Ewan Creek	
Barrier Name	Stanage Bay Rd	
Barrier Type	Pipes	
Comments	Moderate sized pipe culvert crossing that should be replaced with baffled box culverts	
Remediation Solution	Baffled culverts

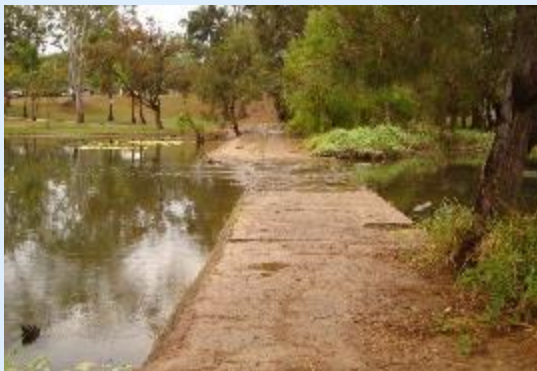
Barrier ID	526	
Stream Name	Police Creek	
Barrier Name		
Barrier Type	Causeway	
Comments	Low causeway that creates a small drop at low flows. Formalisation of downstream ramp require to prevent drops	
Remediation Solution	Rock Ramp Fishway

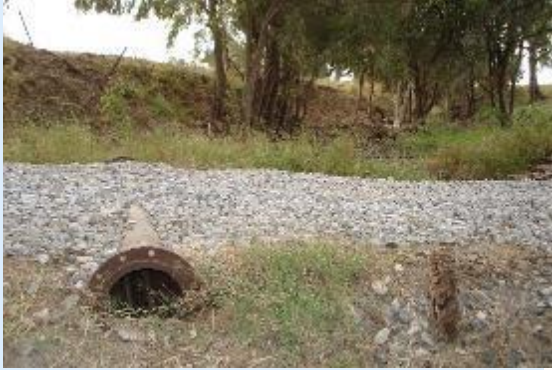
<b>Barrier ID</b>	1032	
<b>Stream Name</b>	Oakey Creek	
<b>Barrier Name</b>	Archer Station Rd	
<b>Barrier Type</b>	Pipe	
<b>Comments</b>	Small pipe culvert crossing that should be replaced with low ford crossing	
<b>Remediation Solution</b>	Ford

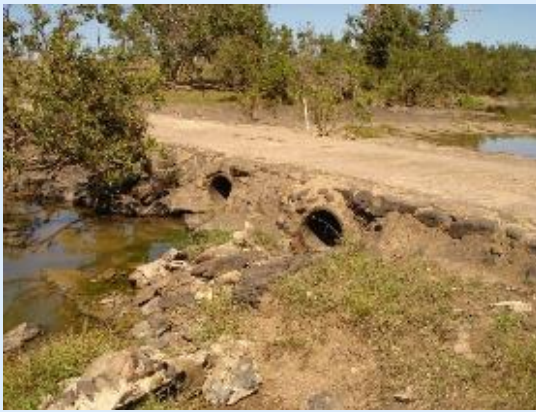
<b>Barrier ID</b>	8784	
<b>Stream Name</b>	Tooolombah Creek	
<b>Barrier Name</b>	Rocky Crossing	
<b>Barrier Type</b>	Causeway/Pipes	
<b>Comments</b>	Small pipe culvert crossing that should be replaced with baffled box culverts	
<b>Remediation Solution</b>	Baffled culverts

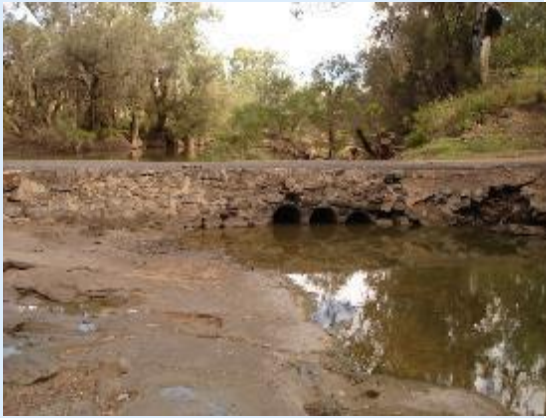
<b>Barrier ID</b>	6348	
<b>Stream Name</b>	Dawson Rver	
<b>Barrier Name</b>	Nun's Crossing	
<b>Barrier Type</b>	Causeway/Pipes	
<b>Comments</b>	Moderate sized pipe culvert crossing that should be replaced with baffled box culverts	
<b>Remediation Solution</b>	Baffled culverts

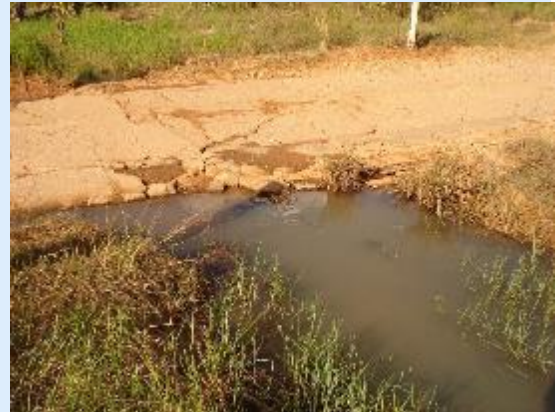
Overall Priority	37
Barrier ID	9550
Stream Name	Block Creek
Barrier Name	Stanage Bay Rd
Barrier Type	Causeway/Pipes
Comments	Small pipe culvert crossing that should be replaced with baffled box culverts
Remediation Solution	Baffled culverts

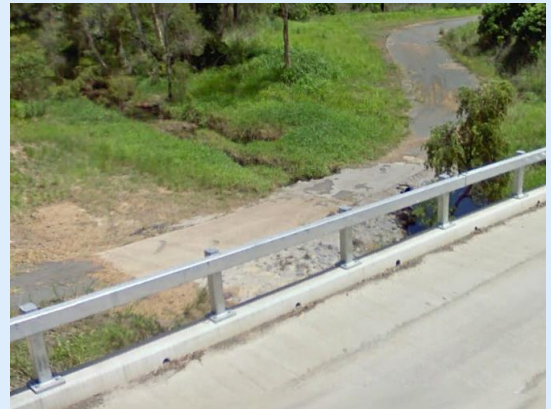
Overall Priority	38
Barrier ID	9192
Stream Name	Clyde Creek
Barrier Name	Wydham Rd
Barrier Type	Pipes
Comments	The crossing has been replaced by a new bridge and is no longer required. Should be removed unless there is local usage of the structure
Remediation Solution	Remove

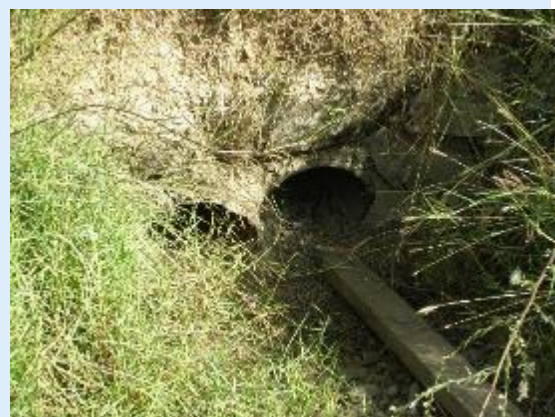
Overall Priority	39
Barrier ID	69
Stream Name	12 Mile Creek
Barrier Name	Langmom Rd
Barrier Type	Causeway/Pipes
Comments	Small pipe culvert crossing that should be replaced with baffled box culverts
Remediation Solution	Baffled culverts

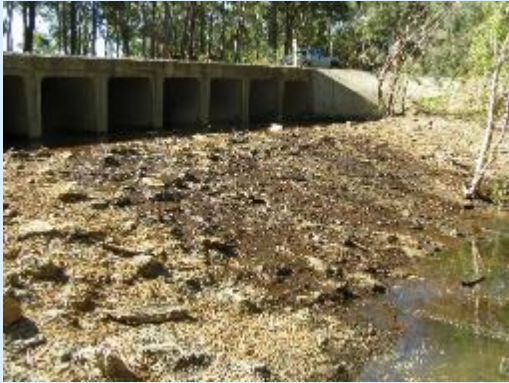
Overall Priority	40

Barrier ID	9041	
Stream Name	Cooraman Creek	
Barrier Name	Cooraman Ck Rd	
Barrier Type	Culverts	
Comments	Many barrelled culvert requires baffles installed in at least two culvert barrels. Marine inundation requires that baffles are stainless steel	
Remediation Solution	Baffles

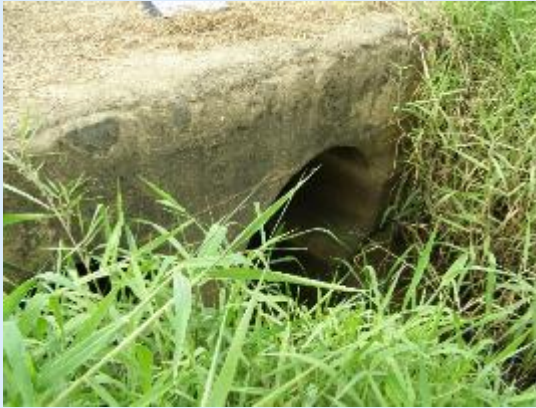
Barrier ID	6144	
Stream Name	12 Mile Creek	
Barrier Name	San Jose Rd	
Barrier Type	Causeway/Pipes	
Comments	Small pipe culvert crossing that should be replaced with baffled box culverts	
Remediation Solution	Baffled culverts

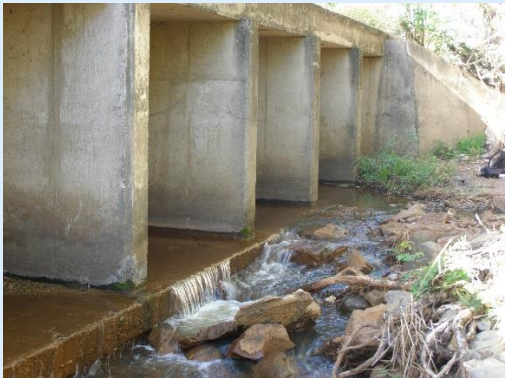
Barrier ID	6198	
Stream Name	Nankin Creek	
Barrier Name	Thompsons Point Rd	
Barrier Type	Culverts	
Comments	Large box culvert that have a drop on the downstream side, will require rock ramp to allow fish to enter culverts	
Remediation Solution	Rock Ramp Fishway/Baffles

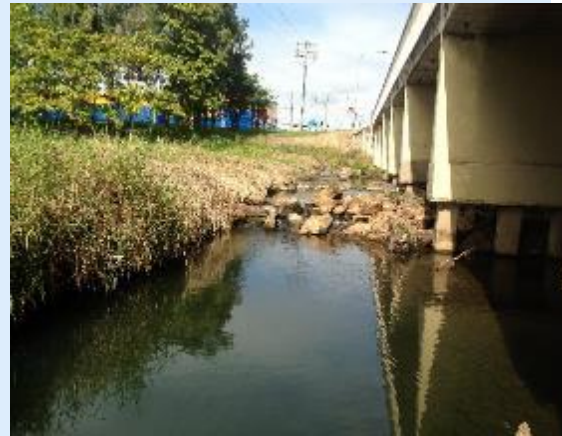
Overall Priority	44
Barrier ID	532
Stream Name	Moore's Creek
Barrier Name	Musgrave St
Barrier Type	Weir
Comments	Small weir with significant erosion downstream under main roads bridge. Last barrier now blocking Moore's Ck
Remediation Solution	Cone Fishway

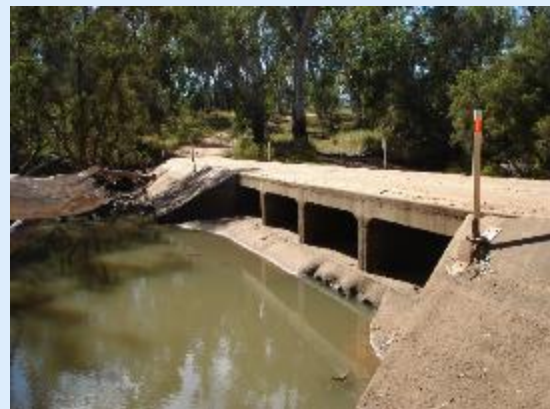
Overall Priority	45
Barrier ID	2664
Stream Name	Dawson River
Barrier Name	Kianga River Rd
Barrier Type	Culverts
Comments	Large box culvert that have a drop on the downstream side, will require rock ramp to allow fish to enter culverts
Remediation Solution	Rock Ramp Fishway/Baffles

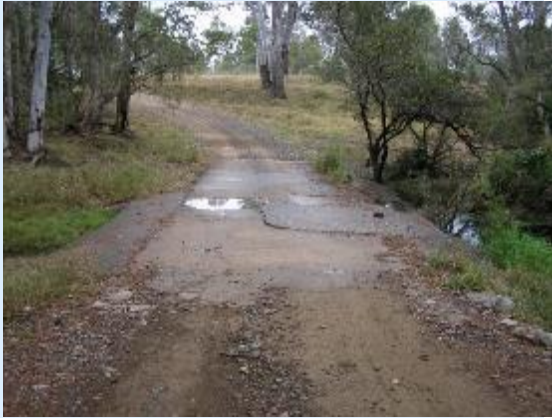
<b>Overall Priority</b>	46

<b>Barrier ID</b>	8606	
<b>Stream Name</b>	Calliope River	
<b>Barrier Name</b>	Duckholes Rd	
<b>Barrier Type</b>	Pipes	
<b>Comments</b>	Small pipe culvert crossing that should be replaced with baffled box culverts	
<b>Remediation Solution</b>	Baffled culverts
