Ensham
R E S O U R C E S

A COLLABORATIVE APPROACH TO RECOVERY FROM AN UNPRECEDENTED NATURAL EVENT

**Presentation to
Fitzroy Flood Forum**

6 August 2008

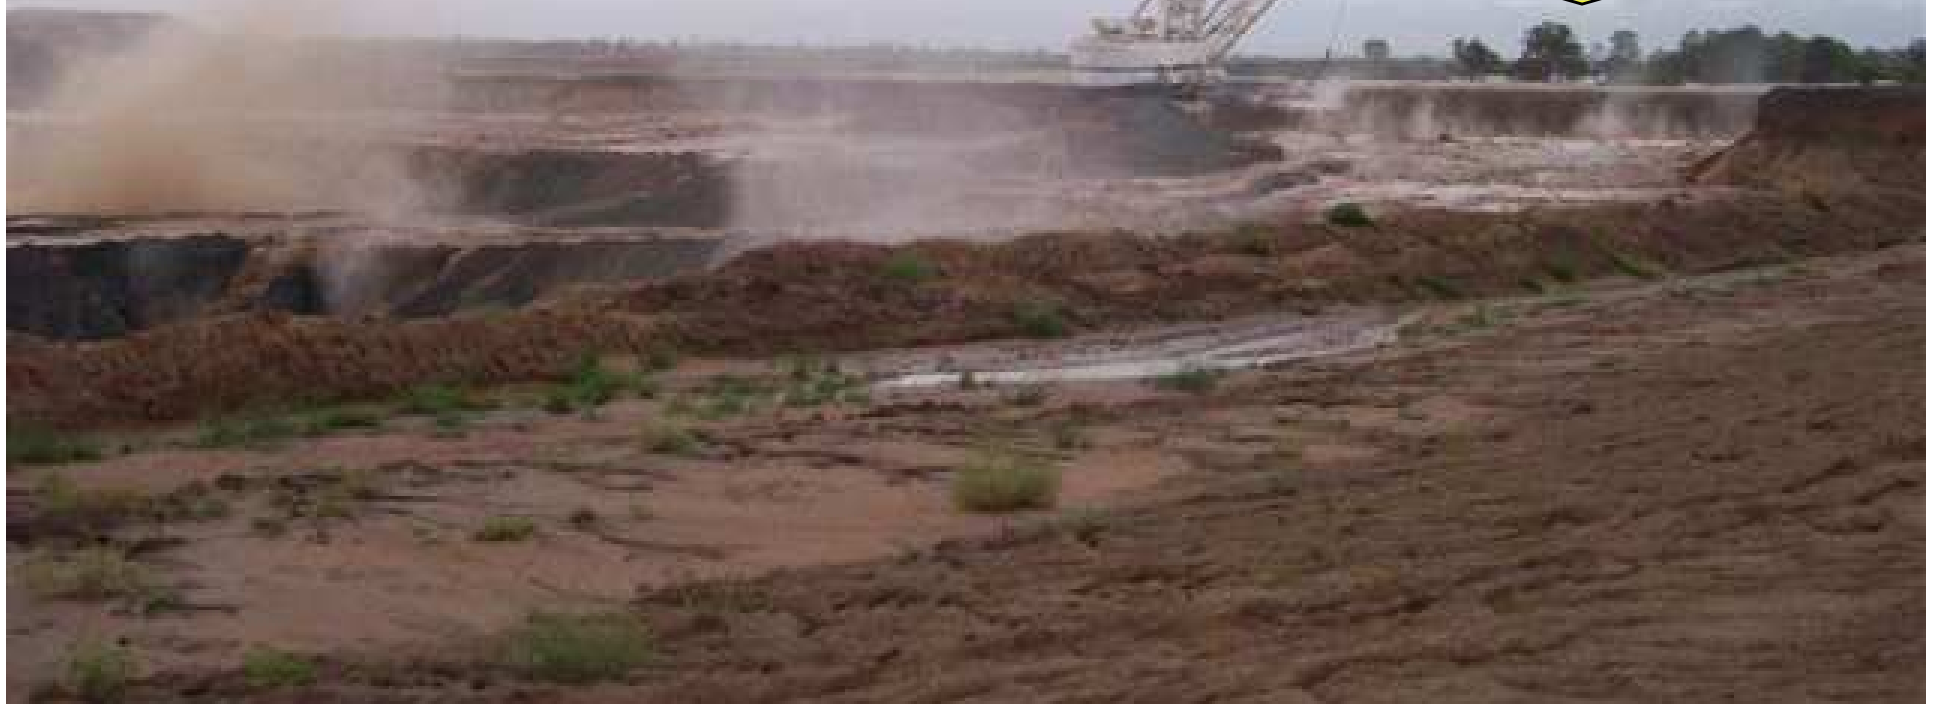
Floodwater Cascades over levees as Overtopping commences

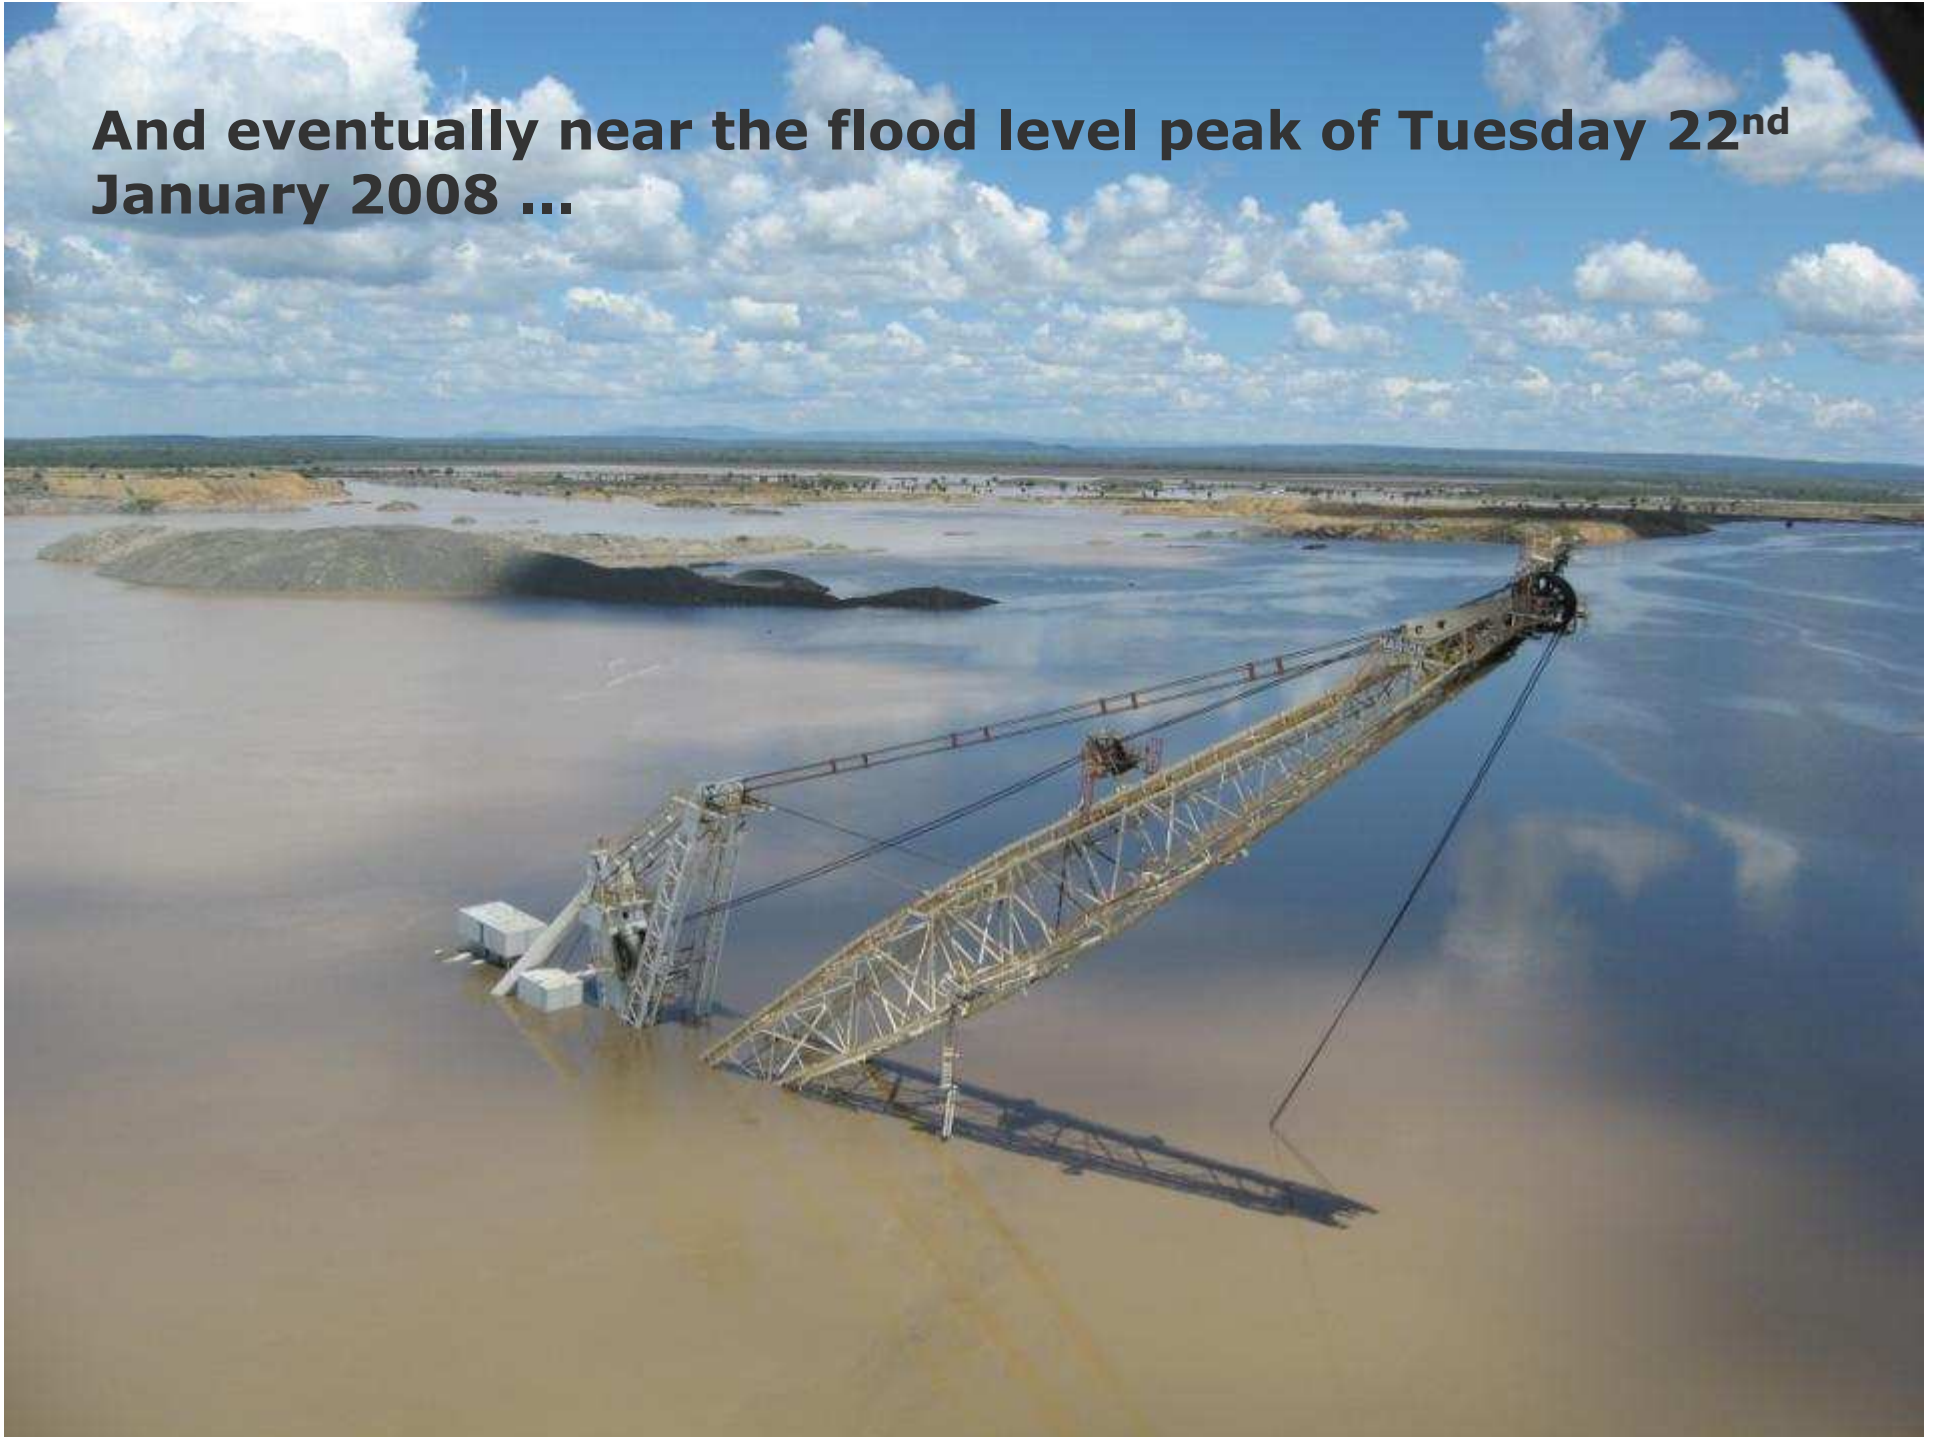
**And eventually near the flood level peak of Tuesday 22nd
January 2008 ...**

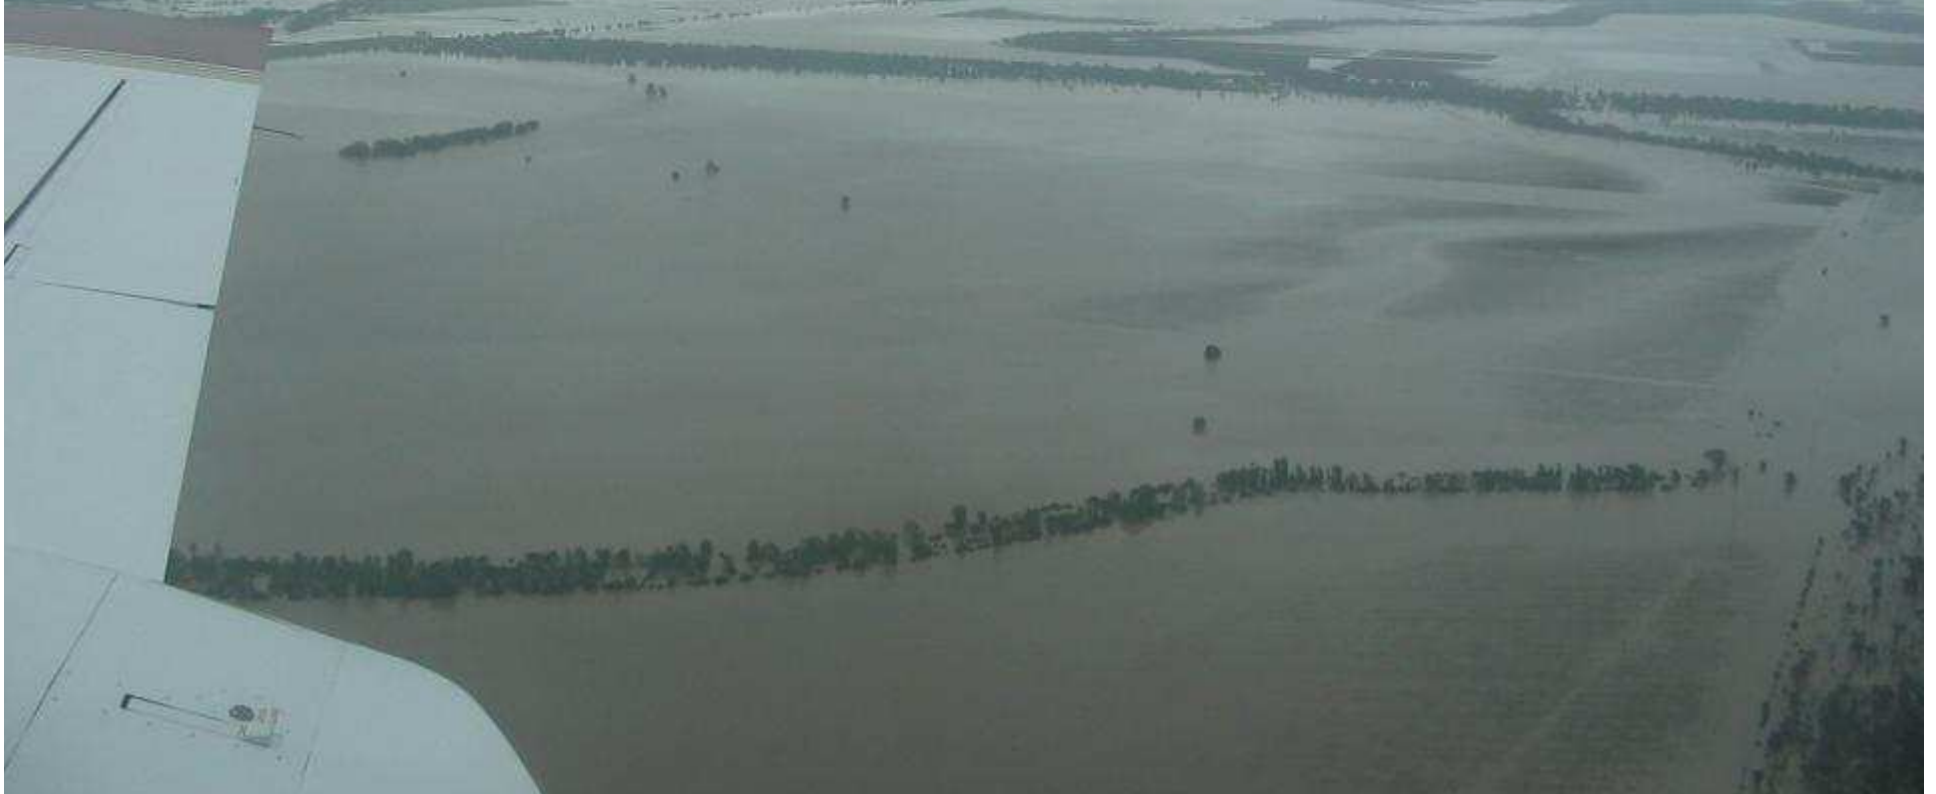
View of the Nogoia River Floodplain area, looking west towards Emerald , on Saturday 19 January 2008, AFTER the floods overtopped the Ensham levees and Inundated Dragline 1...

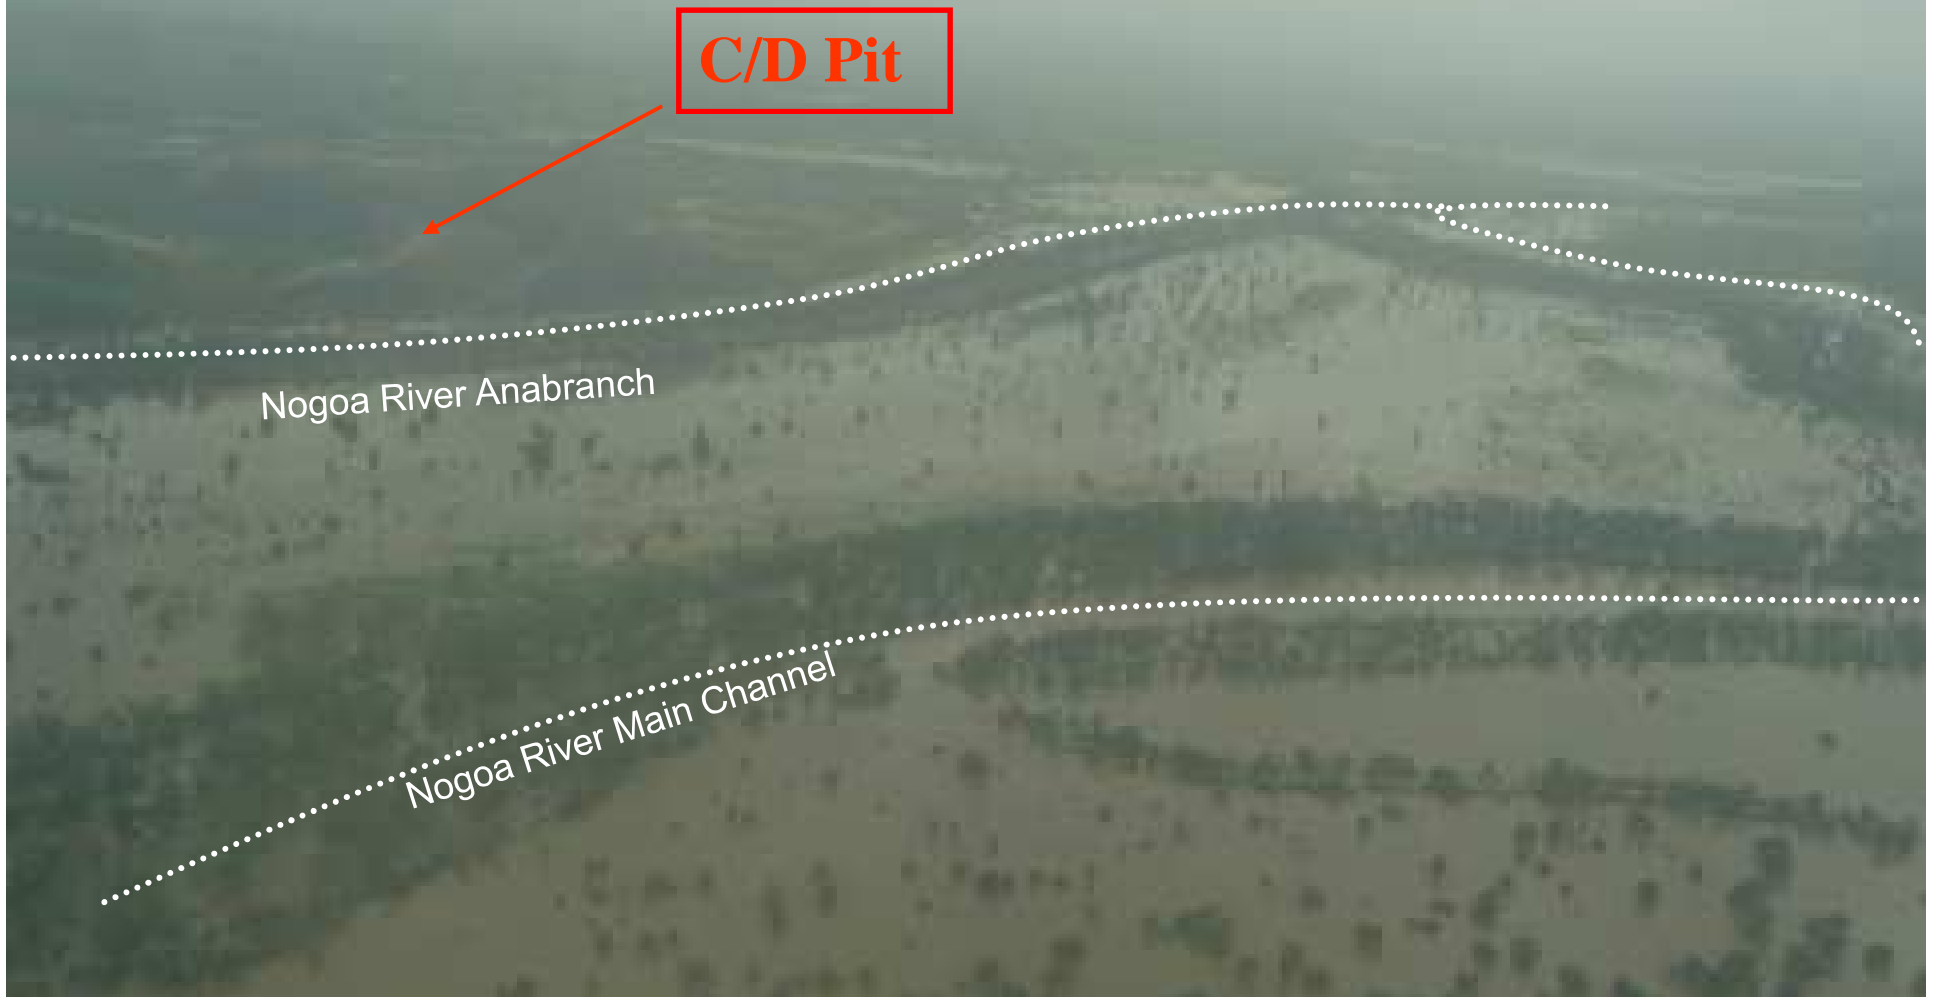
View of the Nogoia River Floodplain area, looking east towards Comet, on Saturday 19 January 2008. Flooding of the Nogoia River Anabranh builds up AFTER Dragline 1 was Submerged

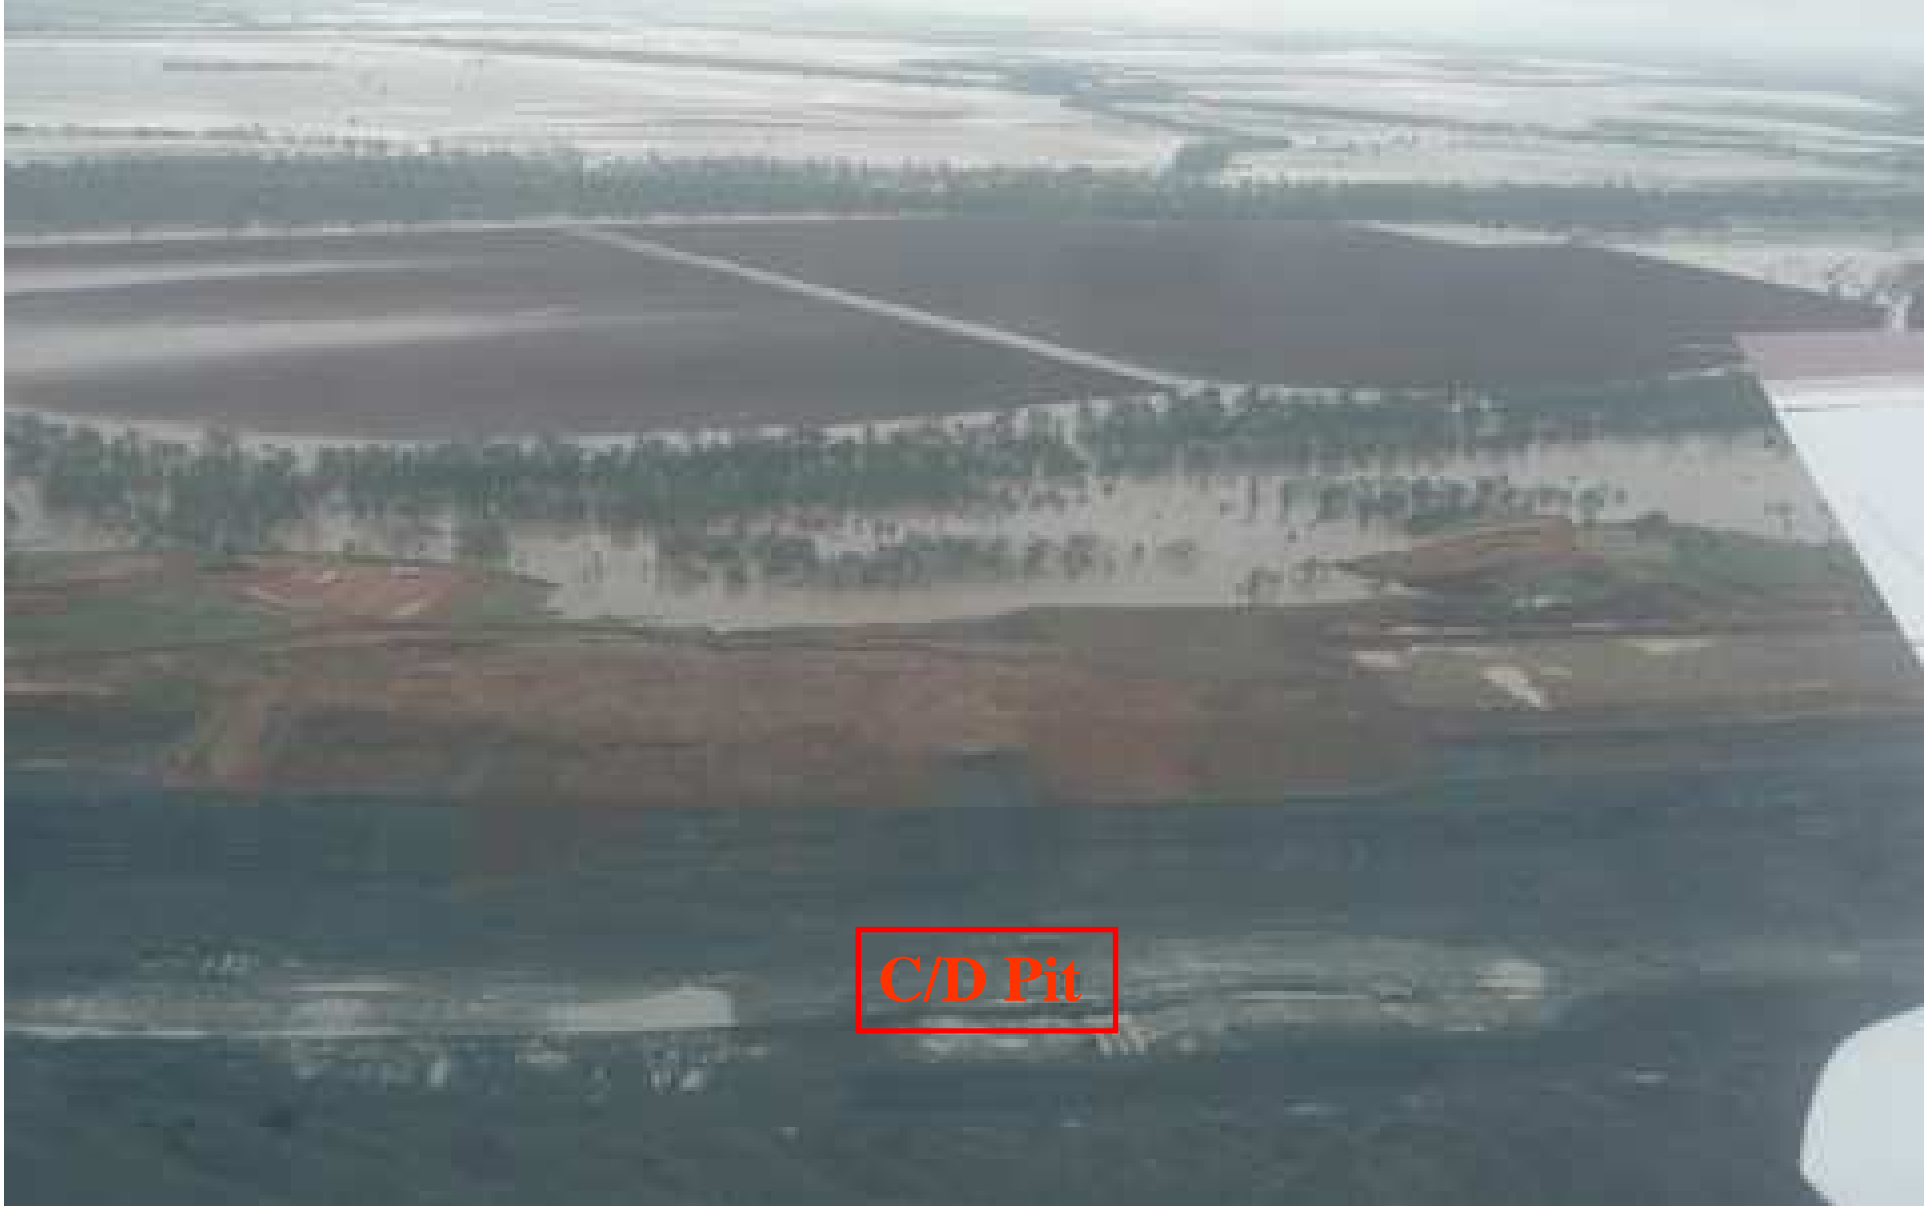
View of the Nogoia River Floodplain area, looking West towards Emerald, on Saturday 19 January 2008, AFTER Dragline 1 was Submerged

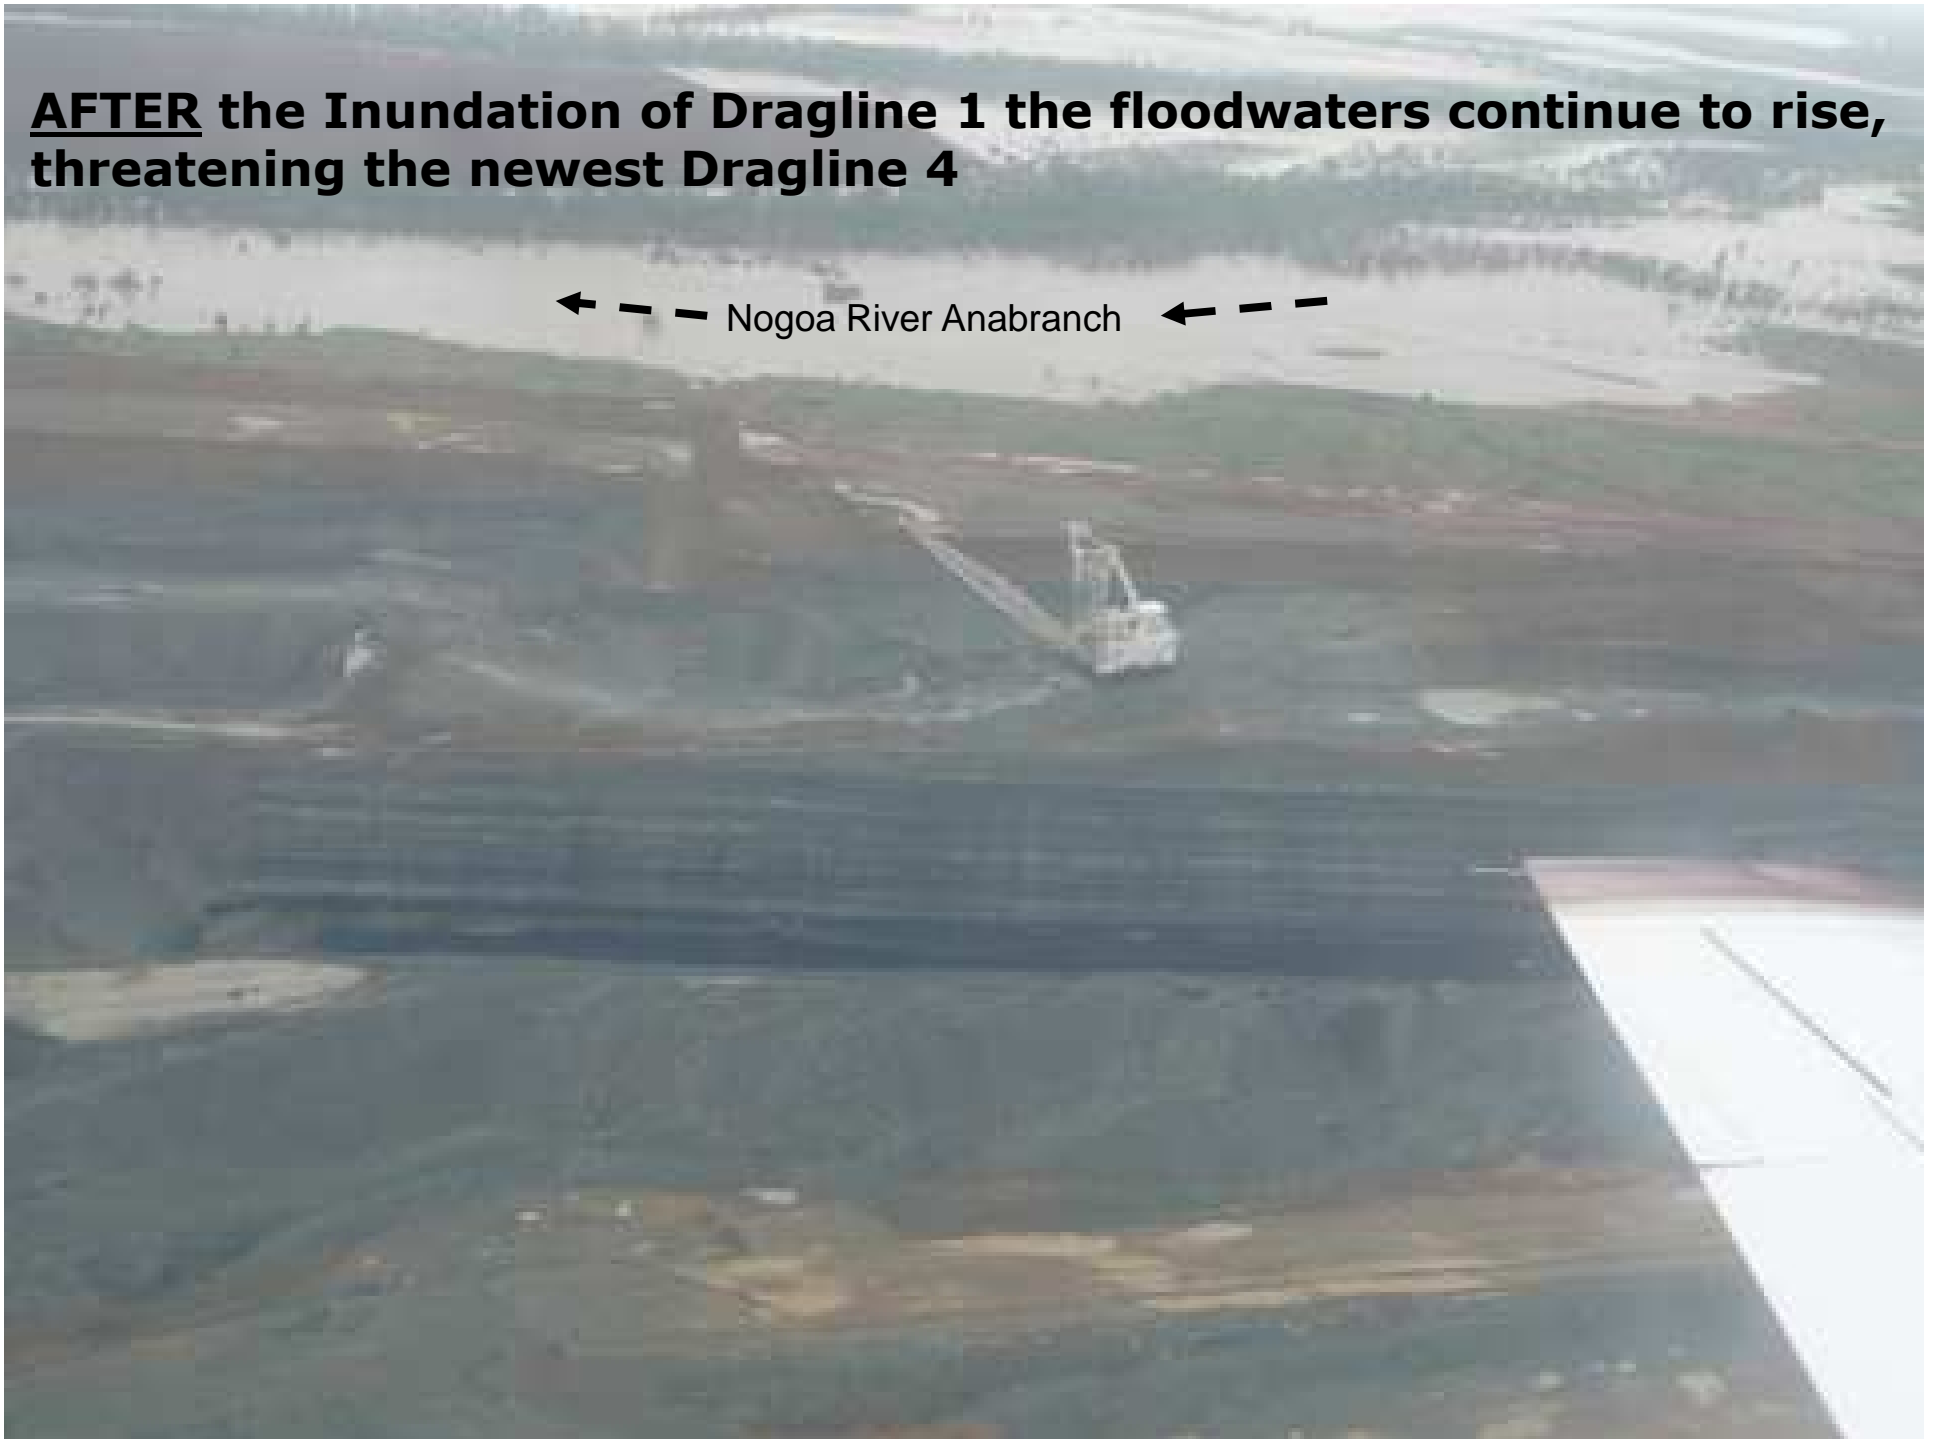
AFTER the Inundation of Dragline 1 the floodwaters continue to rise, threatening the newest Dragline 4

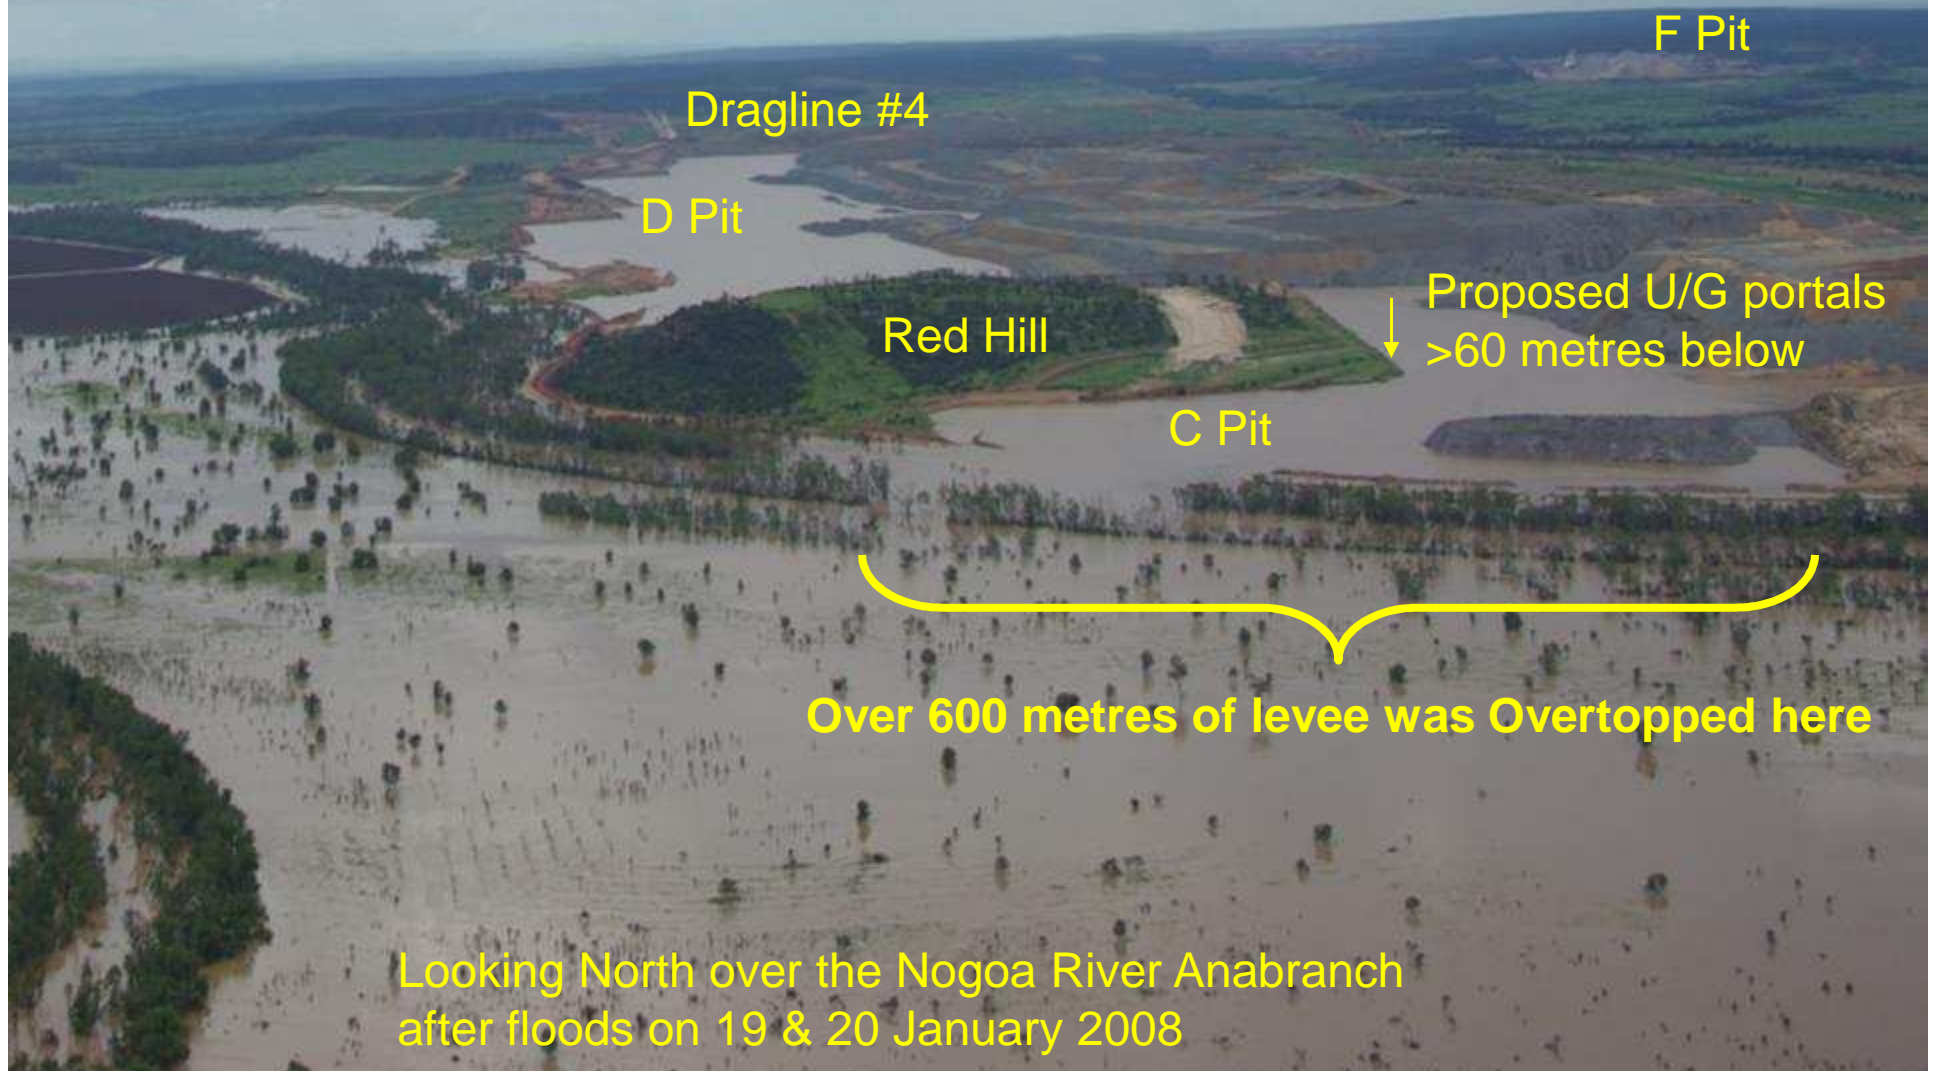
And eventually, near the peak of the flood AFTER Dragline 1 was Submerged and D Pit was Inundated

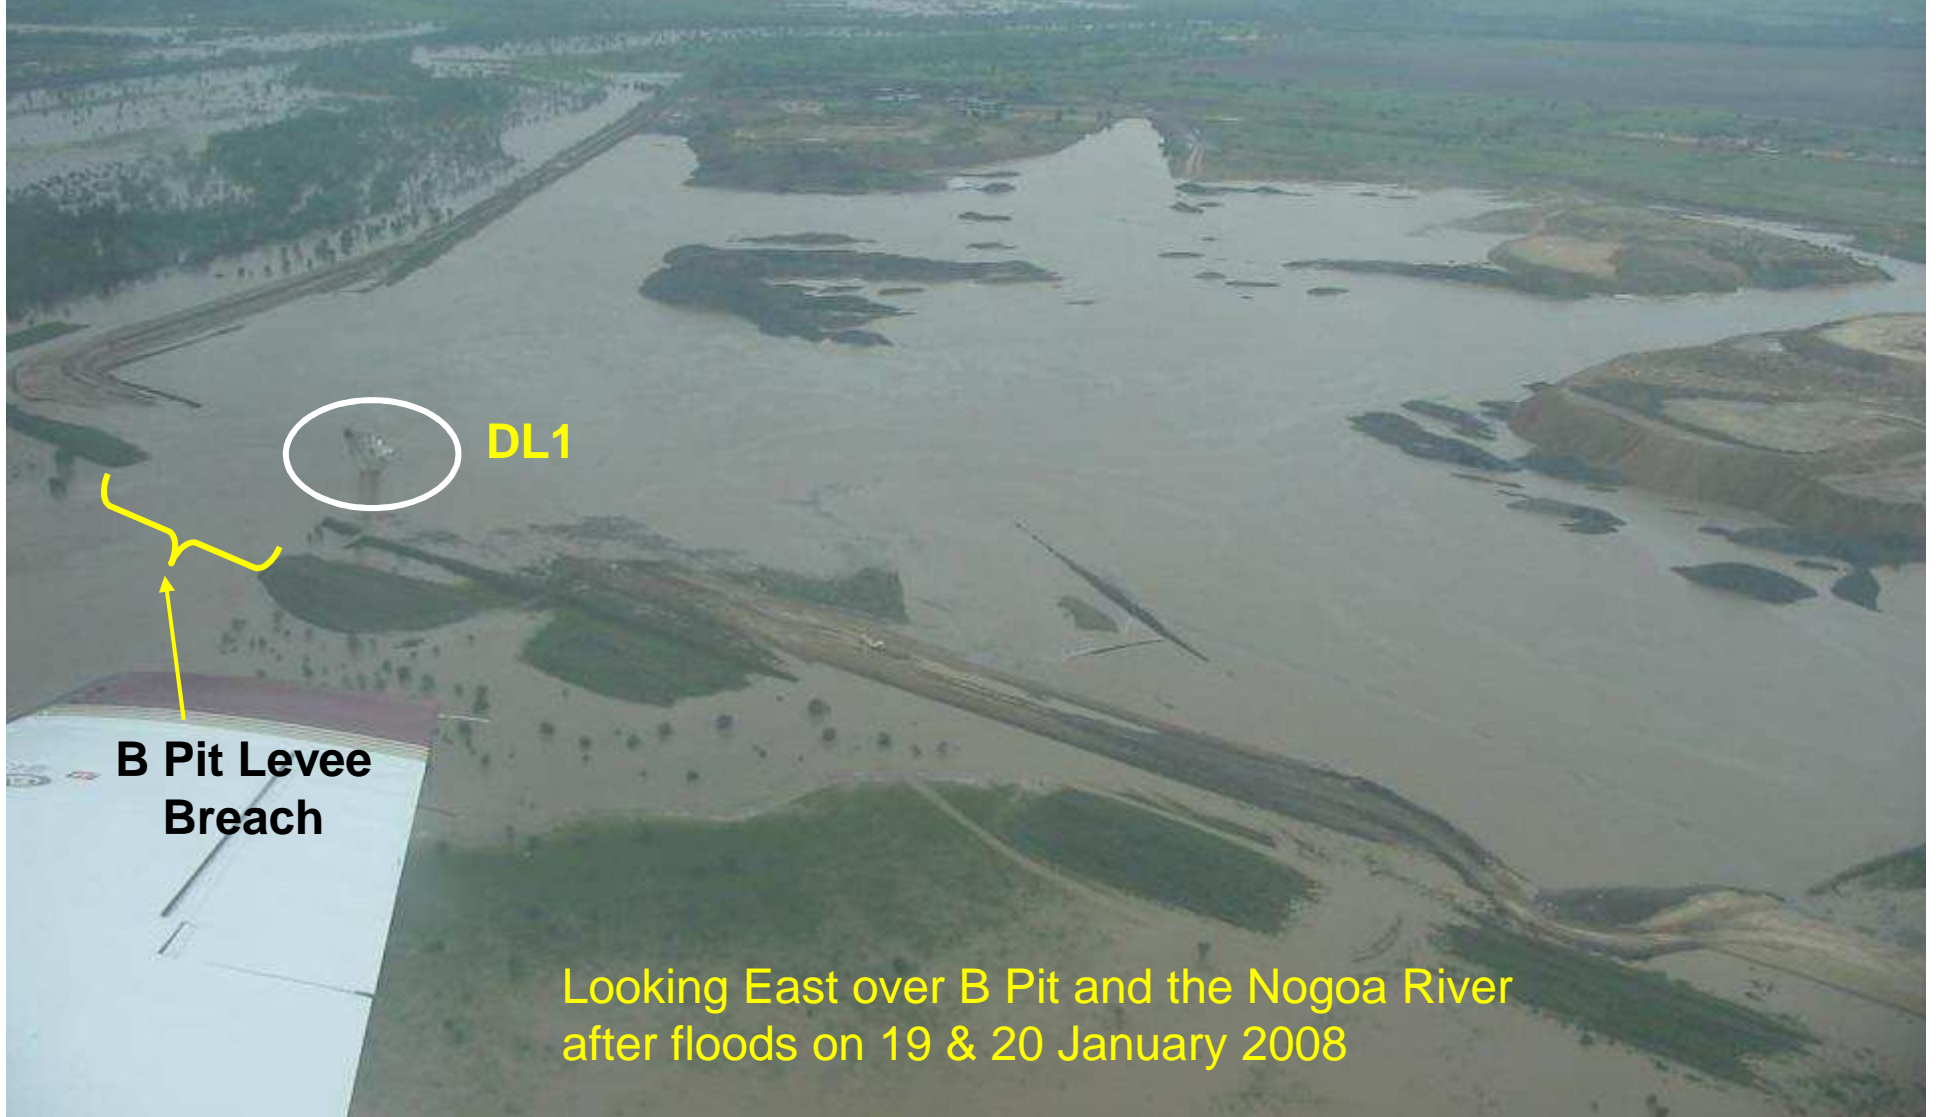
And levees in B Pit continued to overtop, as the river continued to rise, AFTER Dragline 1 was Submerged

Looking East over B Pit and the Nogoia River after floods on 19 & 20 January 2008

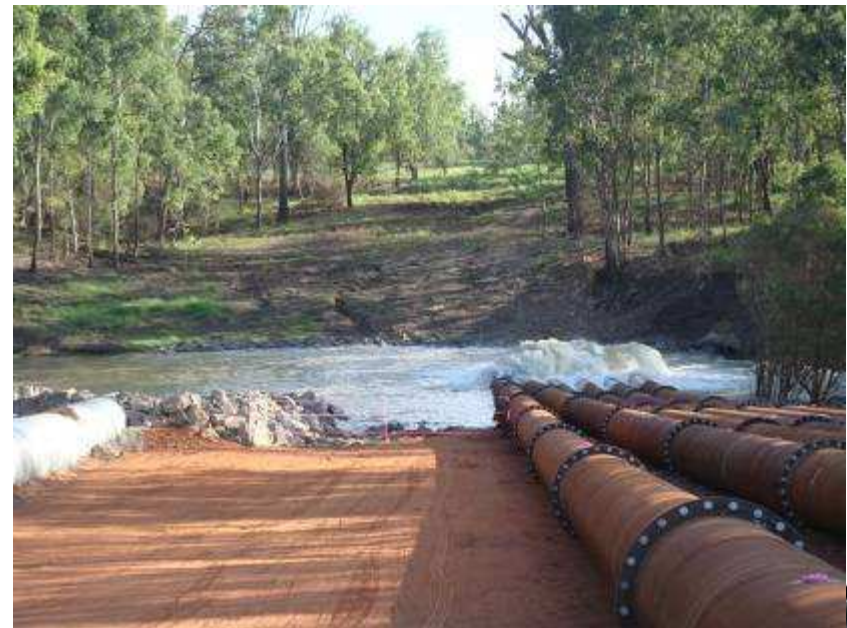
One of several installations – this “mechanical river” returns river water to the Nogoia River from whence it came:

6 x 450hp = 2,700hp (~2,000kW)

720 Megalitres per day

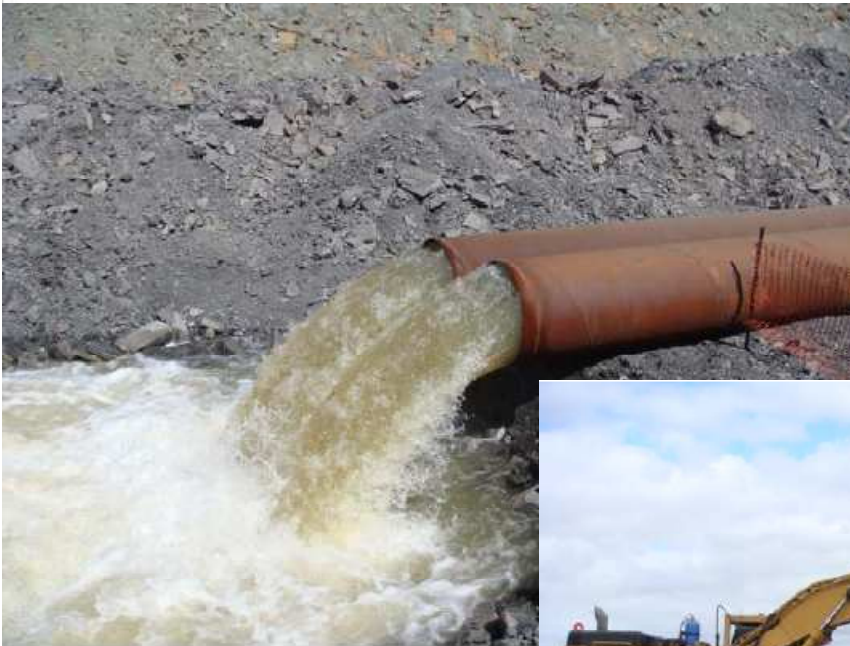
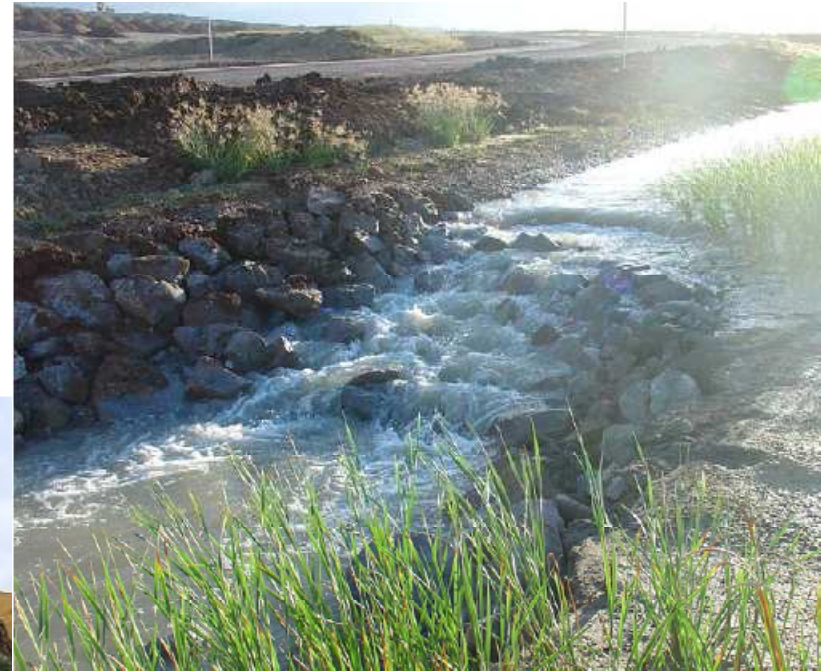
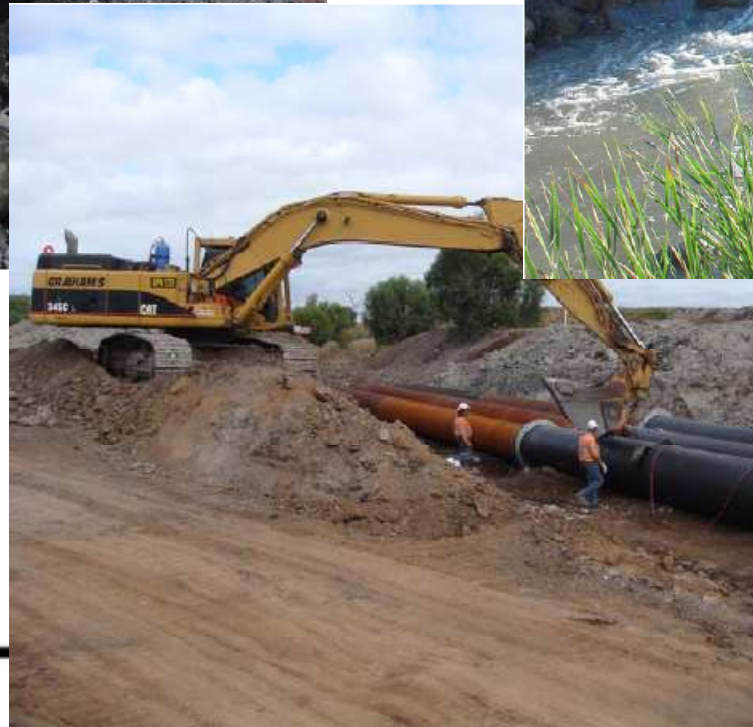
Careful engineering has been used to protect stream beds and banks and aerate water ...

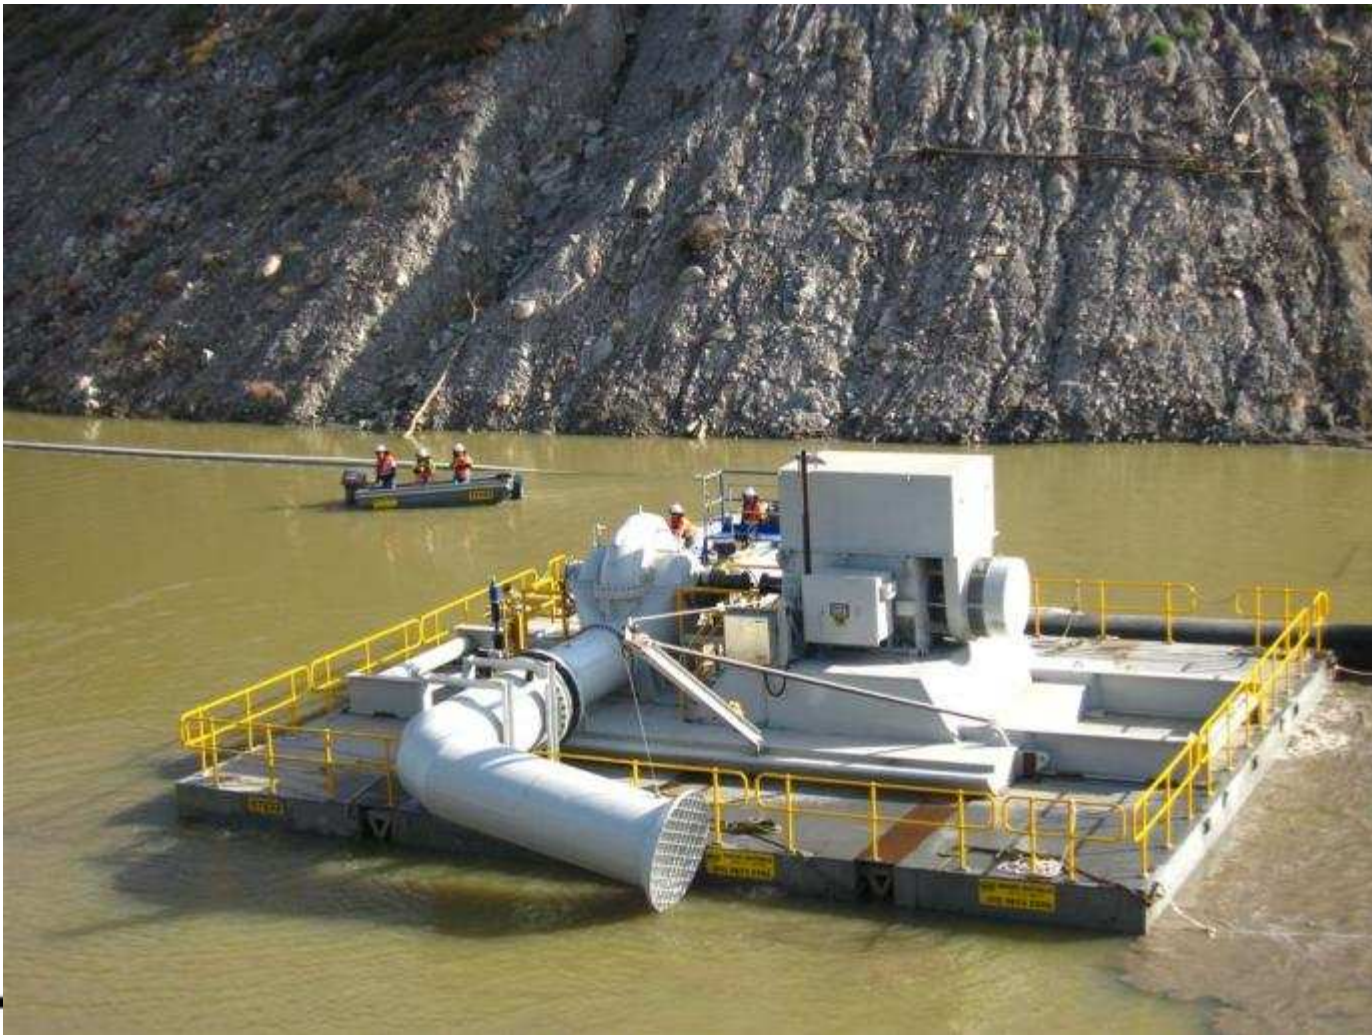
Ensham has constructed and installed two of the biggest dewatering pumps in Australia

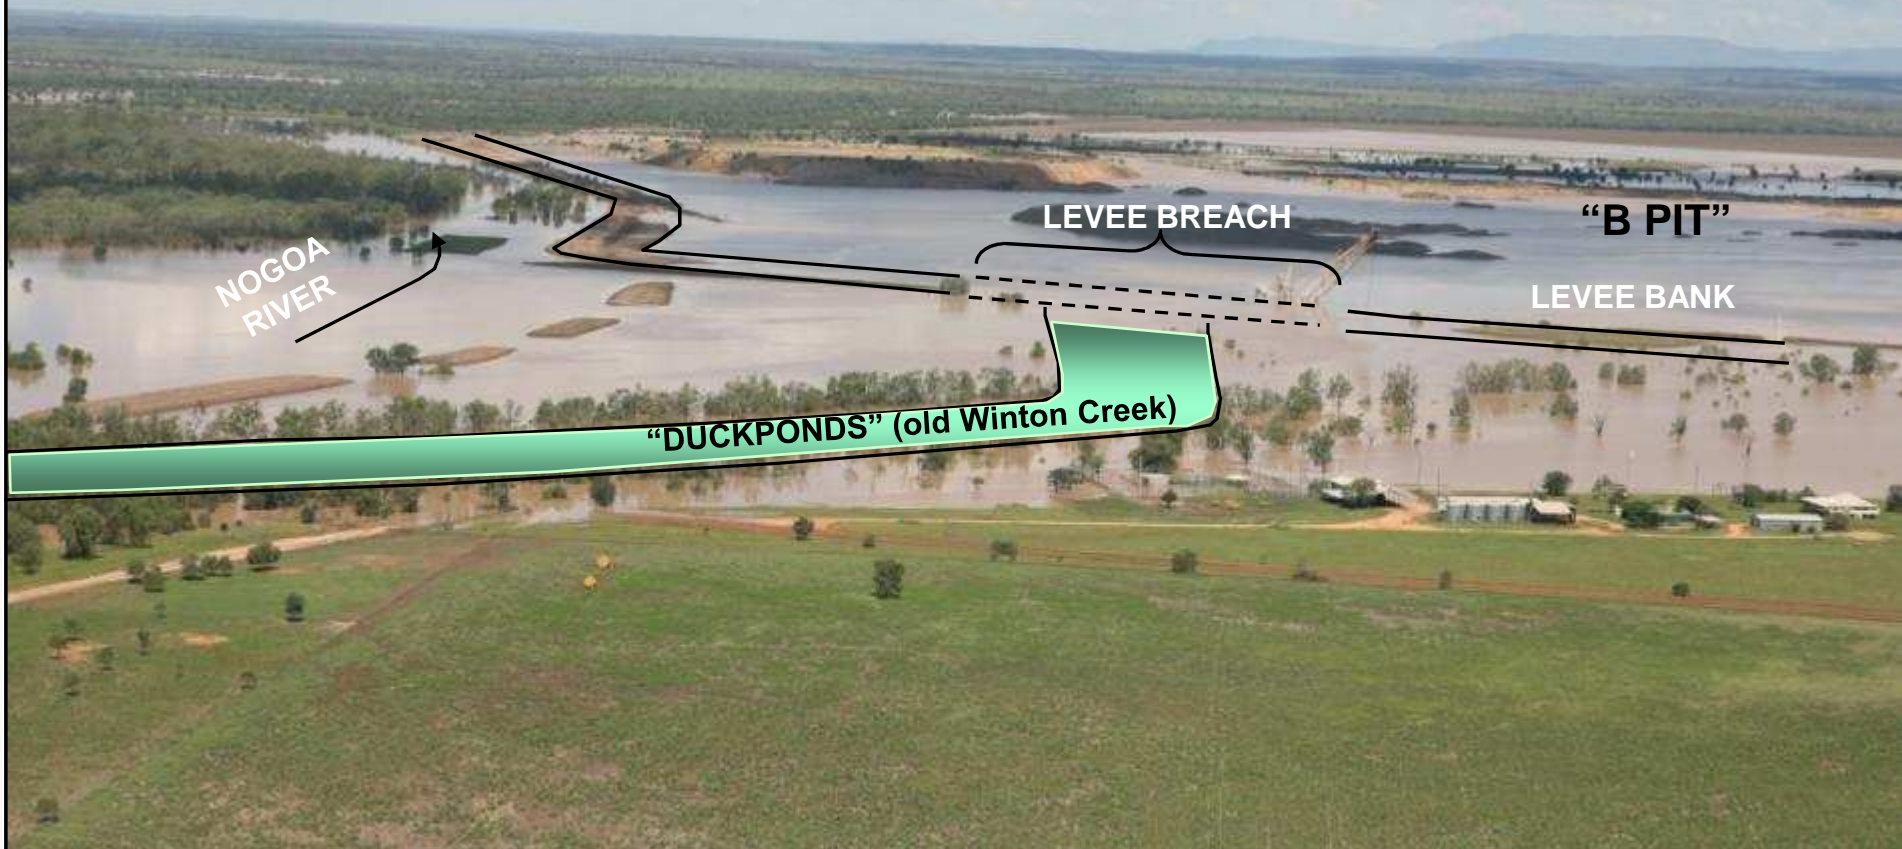
View of "B Pit" looking East

- The B and C/D Pits suffered breaches to their flood protection levees
- Those pits were flooded by inflow of flood waters from the Nogoia River and Theresa Creek
- These levee breaches were substantial and remain open, exposing B and C/D pits to further water inflows during even minor increases in river flow level
- Two such river flow increases have occurred since the major flood event of mid January

B, C and D Pits remain exposed to the risk of inflow during even minor increases in level and flow in the Nogoia River and Tributaries

- The approvals required for new flood protection levees must happen *urgently*
- Applications to the various agencies commenced in Mid 2007
- Very little progress was made in the first 6 months due to different inter-Departmental opinions about how to manage tenure and jurisdictional issues
- Coordination of Government Agencies is required to ensure that required approvals are expedited
