# **Fitzroy Basin Association**

Fish Barrier Prioritisation Update 2015

Tim Marsden

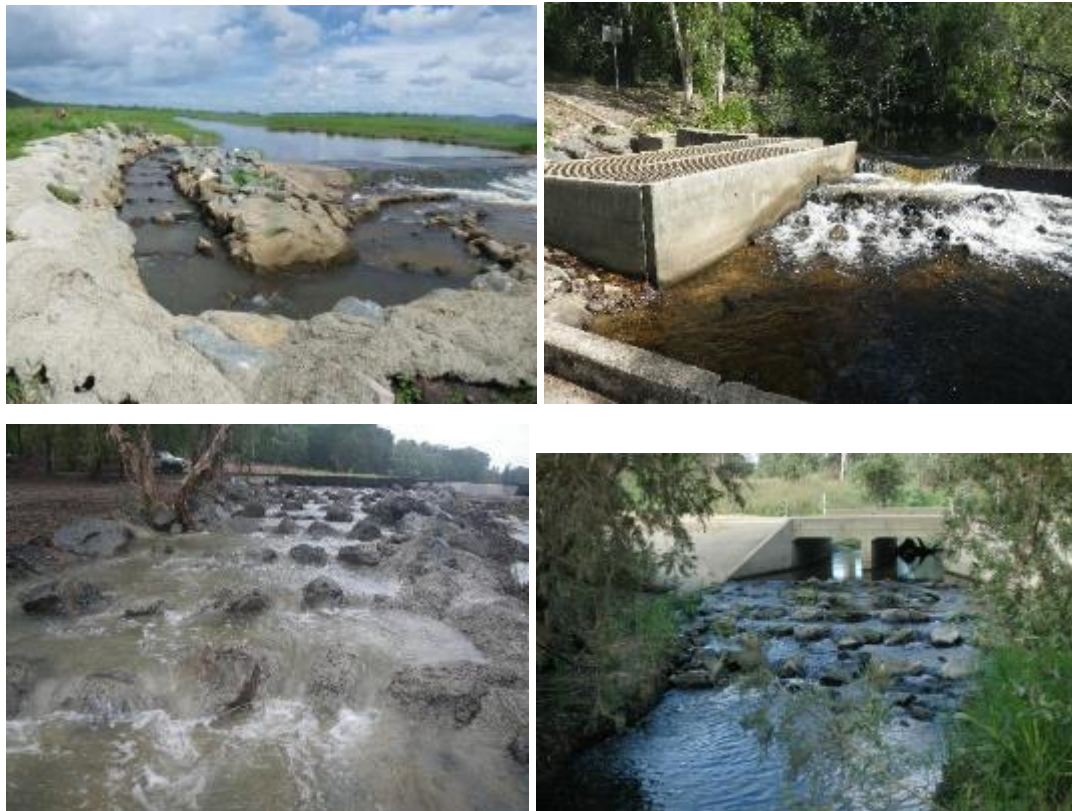
**Figure 1. Four fishways constructed in the FBA Region. A) Amity Ck rock ramp fishway (top left), b) Waterpark Ck vertical slot fishway (top right), c) Moores Ck rock ramp fishway (bottom left) and d) Raglan Ck rock ramp fishway (bottom right).**
