Ensham
R E S O U R C E S

A COLLABORATIVE APPROACH TO RECOVERY FROM AN UNPRECEDENTED NATURAL EVENT

**Presentation to
Fitzroy Flood Forum**

6 August 2008

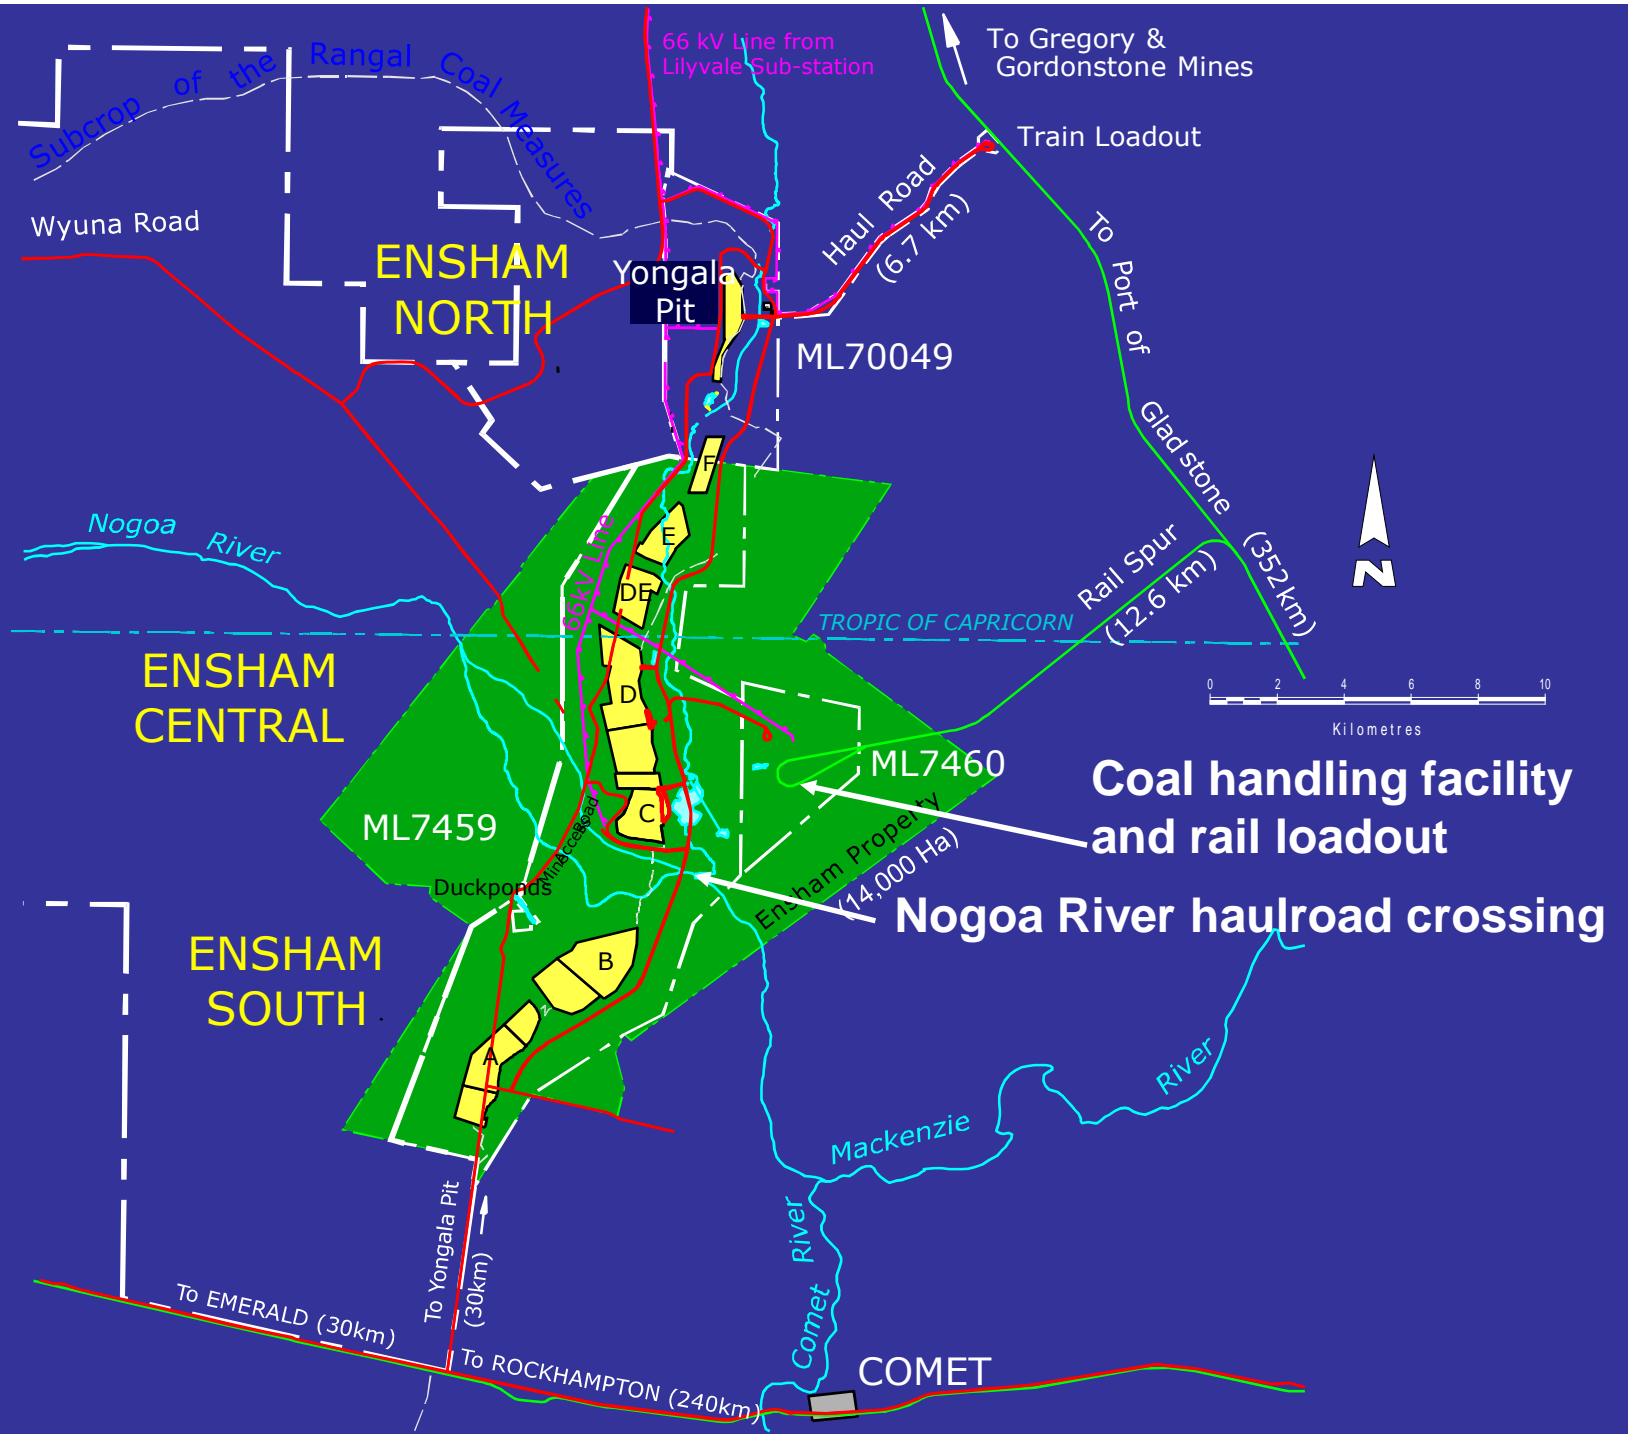
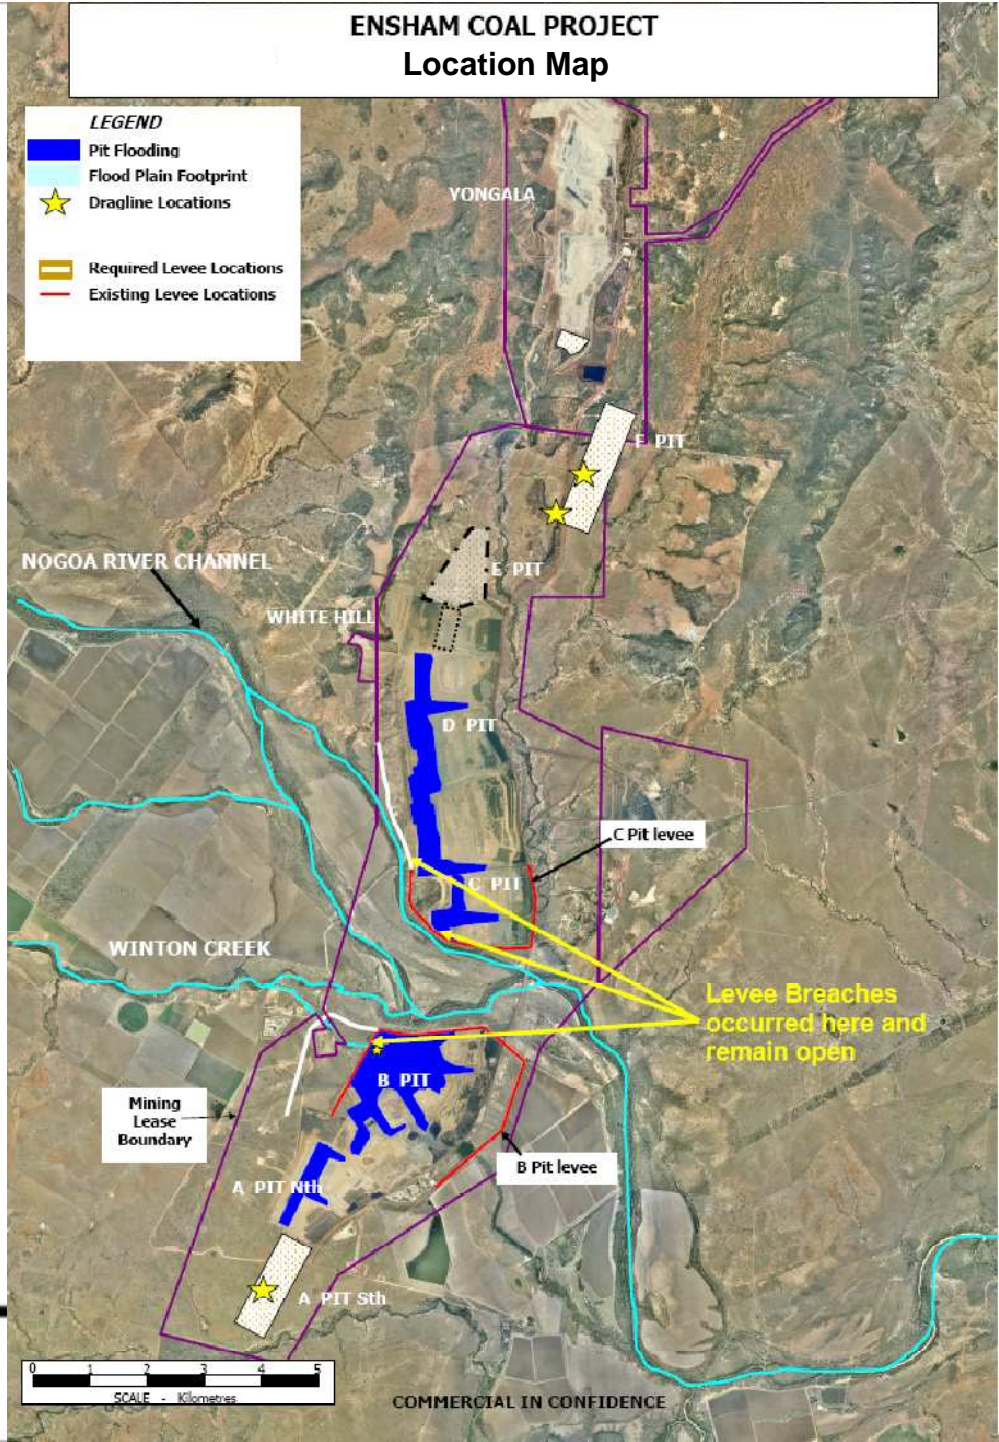
ENSHAM COAL PROJECT Location Map

- Pit Flooding
- Flood Plain Footprint
- Dragline Locations
- Required Levee Locations
- Existing Levee Locations

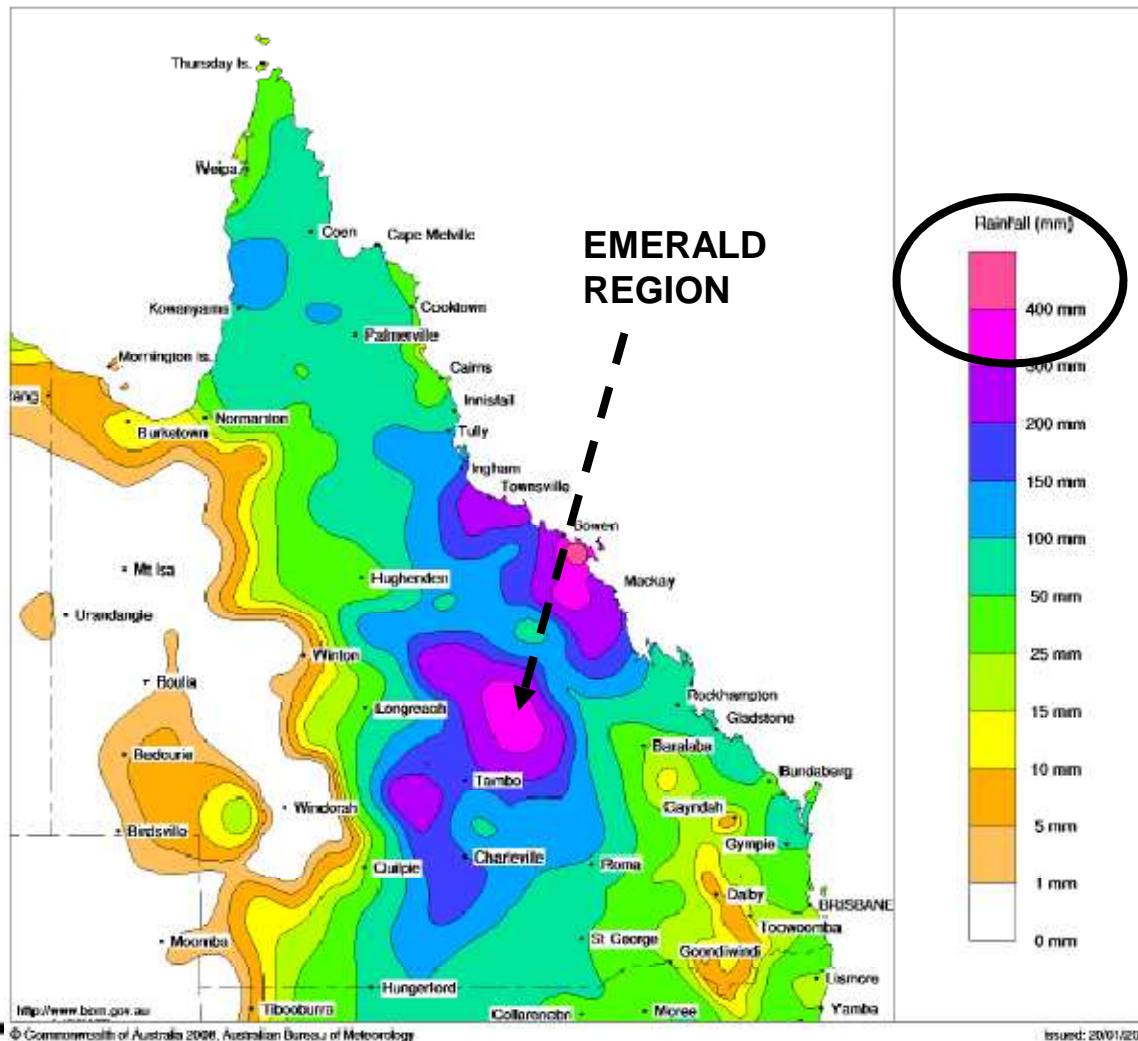
Some "Very Intense" rainfall events occurred in the sections of the Theresa Creek catchments in the 48 hours prior to flooding at Ensham

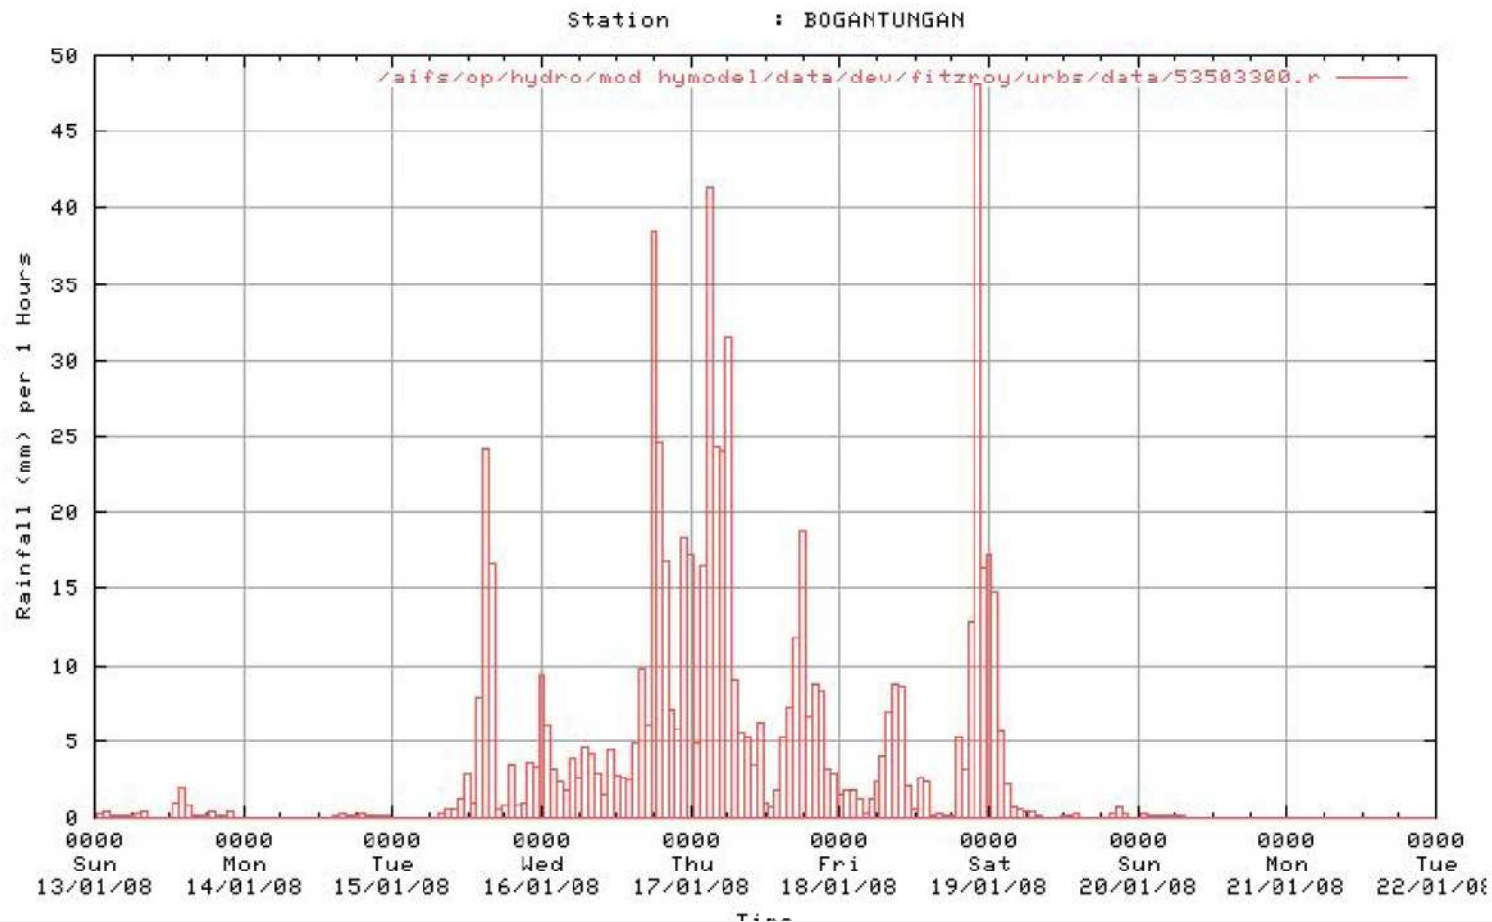
Hourly Hyetographs for Bogantungan

The Intense rainfall events in these Catchments, occurred in the 3 days prior to the Inundation of the Ensham mine – Slide 1

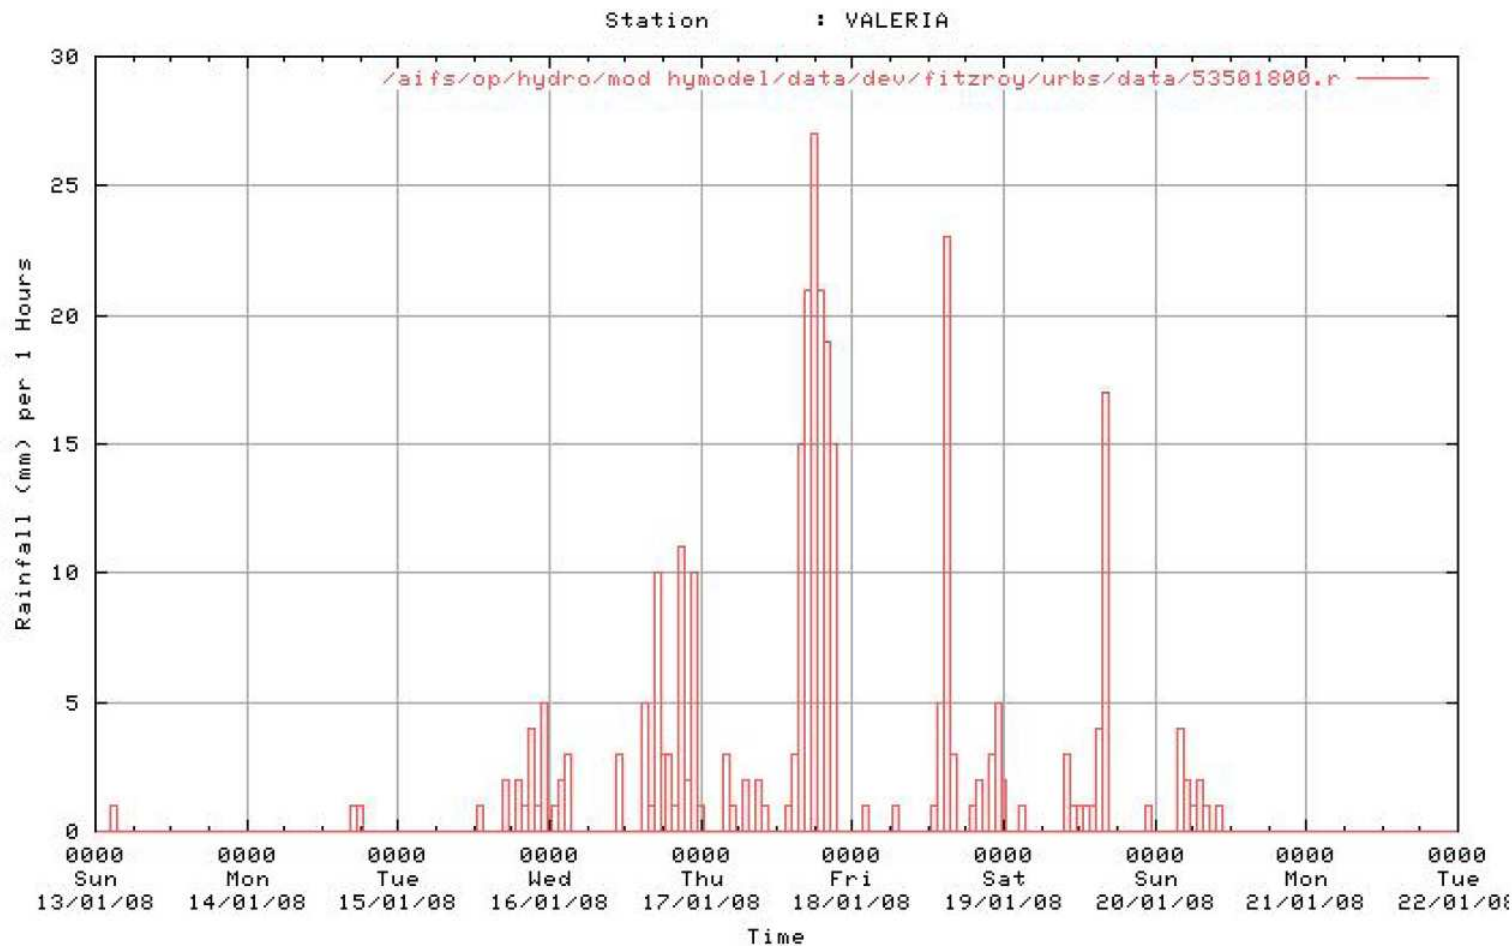
Hourly Hyetographs for Valeria

The Intense rainfall events in these Catchments, occurred in the 3 days prior to the Inundation of the Ensham mine – Slide 2

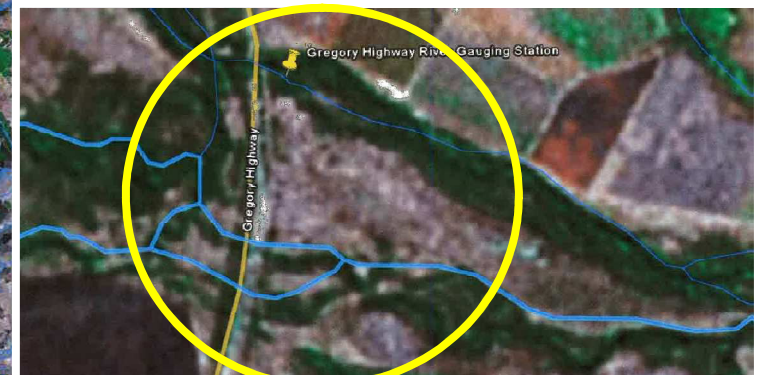
But the Theresa Ck gauging station on the Gregory Highway didn't warn of the severity of this flood because it misses much of the flow from the S-W catchment area

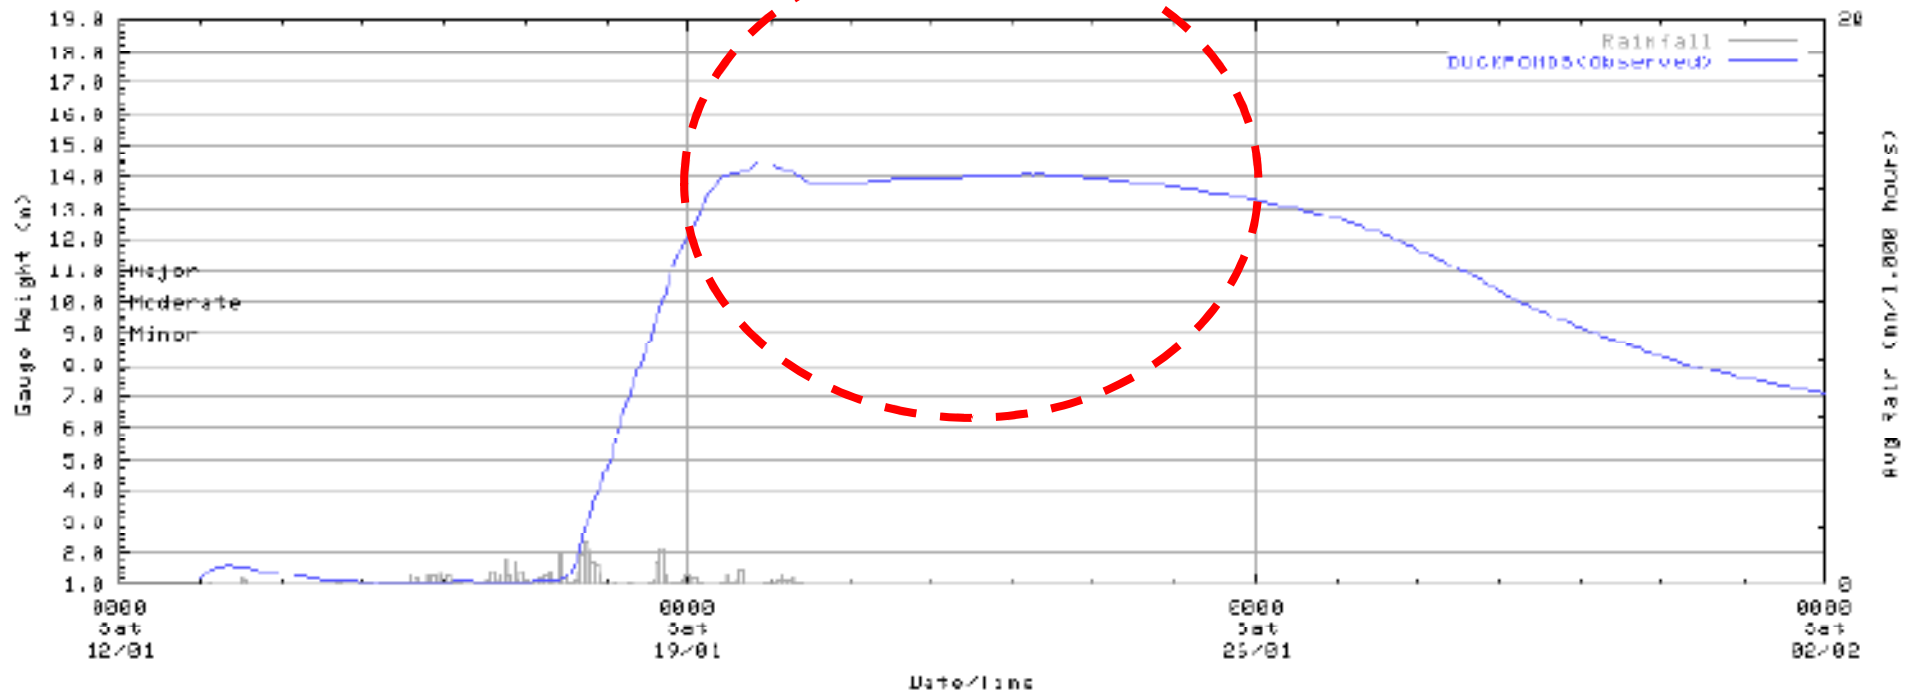
Duckponds – Nogoia River

Two “Fairbairns Dams” of water flowed over Ensham for more than one week before the flow started to recede ...
